Unison™ Technical Support and Service Field Service Report

CRM Case #	69-38376	Job Name:	Casper College
Sales Order #	210261	Serial # or Tags:	AHU-1
Ship Date:	2/28/2011	Rep Office:	LONG

To determine why the building is vibrating below the Innovent unit and to do a complete review of the unit condition and operation.

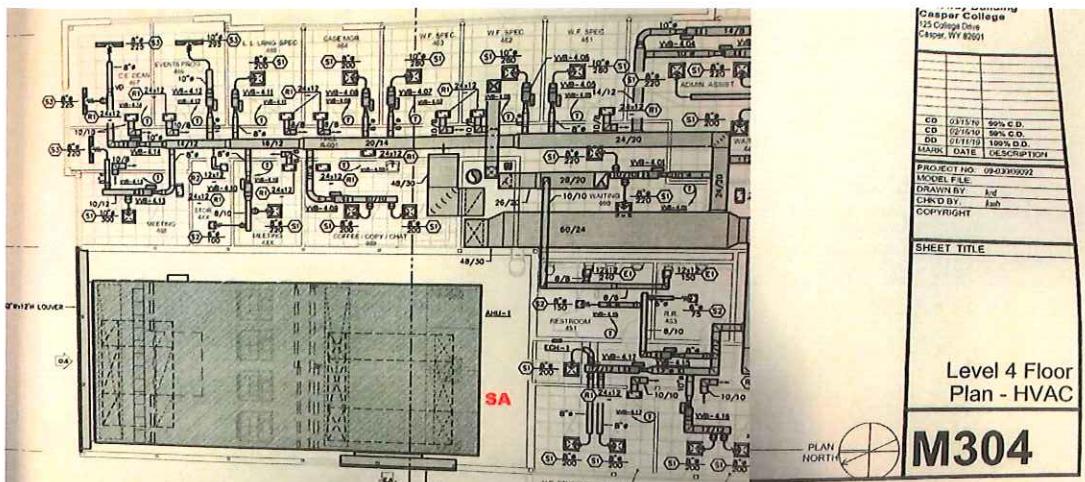
- c. Supply Ducting
 - i. Ducting immediately splits to 3 different trunks to serve the four floors. (F1.1 & F1.2)
 - ii. No common ducting trunk before separation.

F1.1: Building Plans for 4th Floor [Supply Air Ducting]

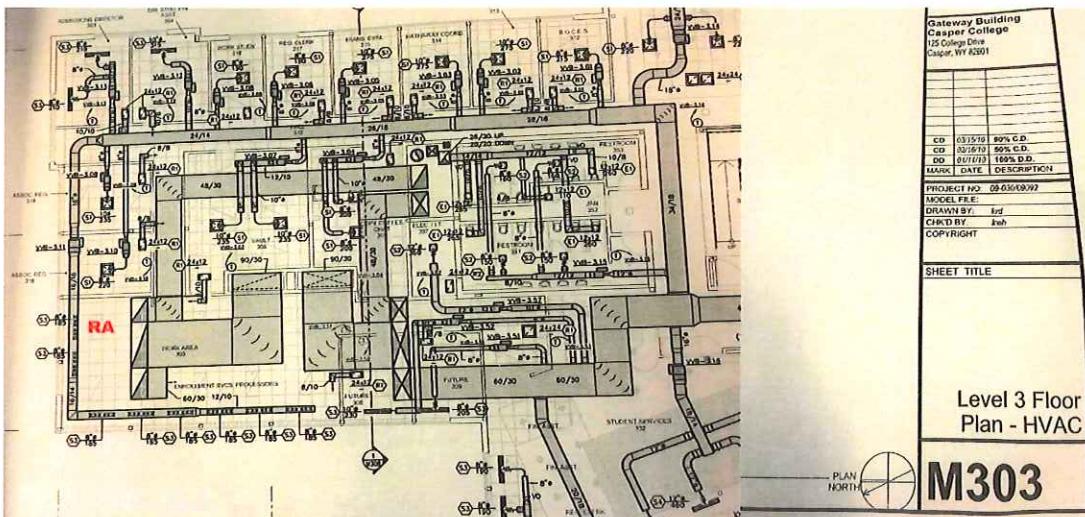
F1.2: Building Plans for 3rd Floor [Return & Supply Ducting]

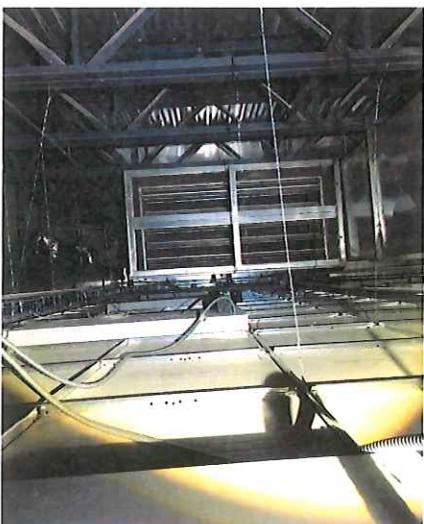
- 2. There are wall separations with no return path for air from areas of building opposite of the unit.
 - ii. 3rd Floor office below the unit and at the return duct had ceiling panels removed. The door from the main concourse to this office became a wind tunnel. (P1.1)

- 1. Damper on return duct was rattling excessively.
 - a. Is this a fire/smoke or return damper?

P1.1: Return Duct from 3rd Floor Ceiling [Just below unit]

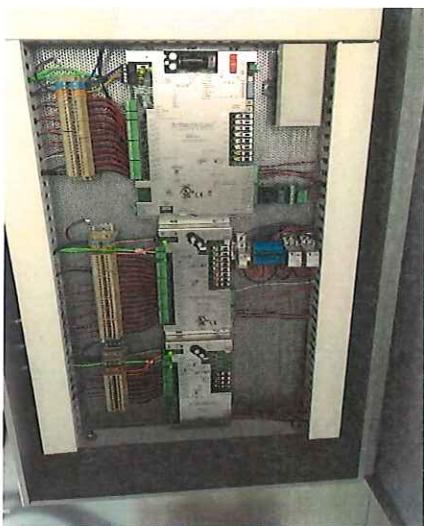
3. Carel Controls removed, and Automated Logic installed. (P1.4)
 - a. Stated was done 2-3 years ago.
4. Internal Components
 - a. Right recirculation damper was closed. Found that the actuator linkage had fallen off.

P1.4: Automated Logic Control Panel within Exhaust Section of Unit

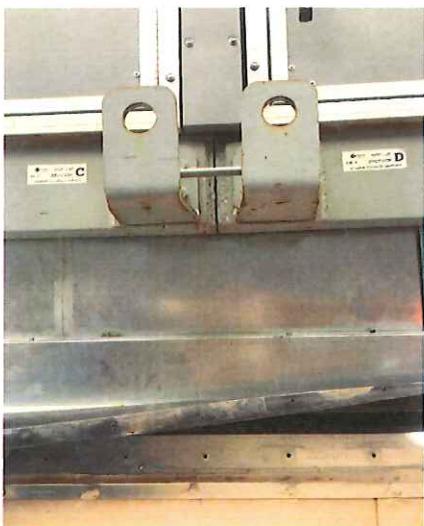
1. Split Connections
 - a. Separation Panels NOT silicone sealed (P2.1)
 - b. Roof flashing at splits NOT fastened (P2.5)
 - c. Curb supports at unit splits not supported to slab nor does it have spring isolation.

P2.1: Base Split Connection at Section C & D

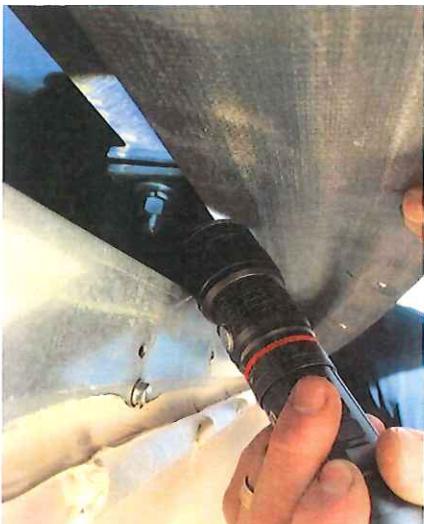
P2.3: Isolation Curb Springs and Mount Not Level

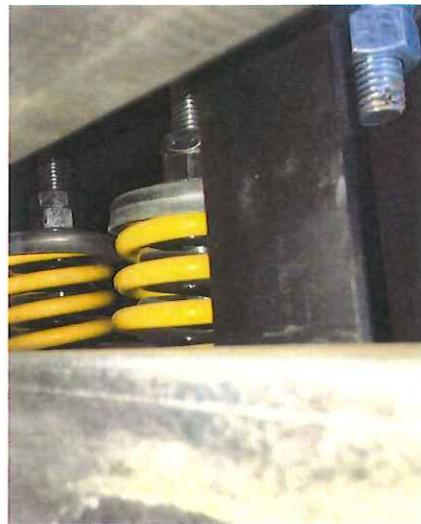
P2.4: Isolation Curb Springs at Section C

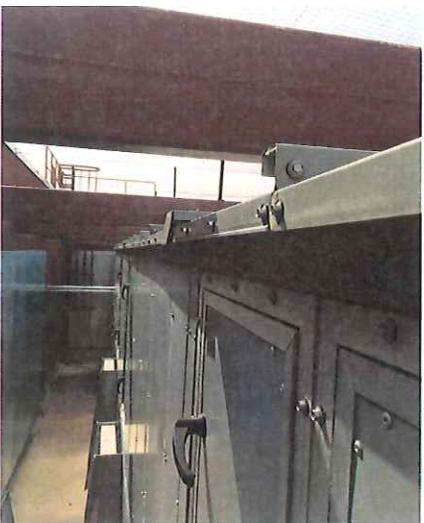
P2.5: Roof Flashing Not Fastened at Splits

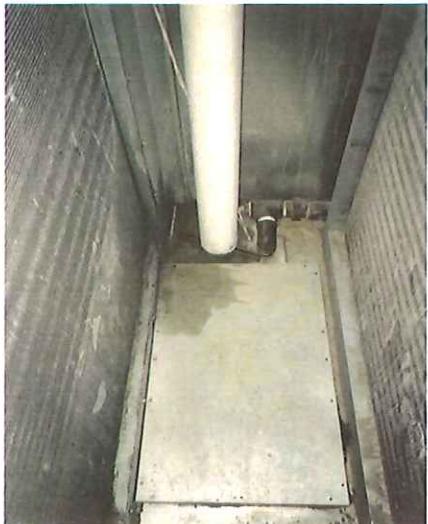
P2.6: HWC Piping Run Through Unit Flooring, Not into Pipe Chase

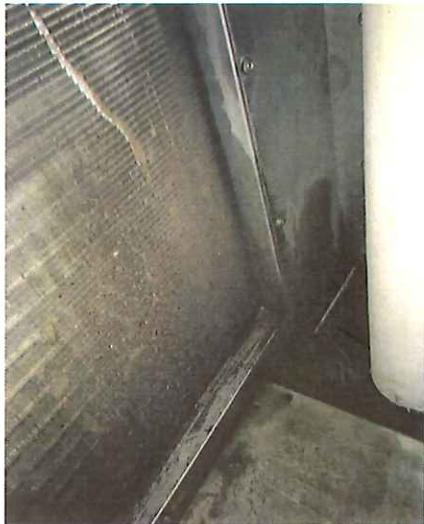
- ii. In the lower right corner of the right coil (air hitting back of head) there appears to be a potential refrigerant leak. (P2.7)
 - f. Supply Air Discharge Compartment

P2.7: Lower Right Corner of DX Cooling Coil - Potential Leak

7. Repair exhaust fan #3 motor.
8. Replace dirty filters on a regular basis.
9. Routinely check correct damper & actuator operation, annually.
10. Routinely check blower & motor operation, annually.
11. Routinely check the refrigeration system operation, annually.

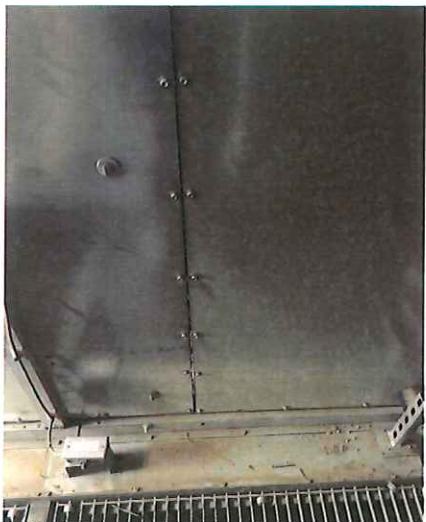
- i. Section A wall (separates SA with EA) has some gaps between wall sections and at corner. (P3.1, 3.2 & 3.3)
 - ii. Attached SA ducting is immediately reduced (unit SA discharge duct is 41" W x 275" L).

P3.1: Supply Discharge Compartment - Gap in Section A Wall

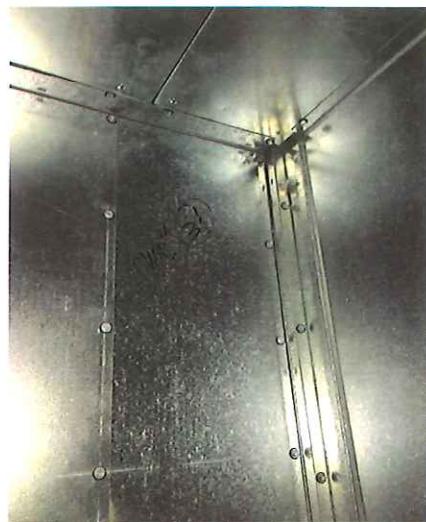
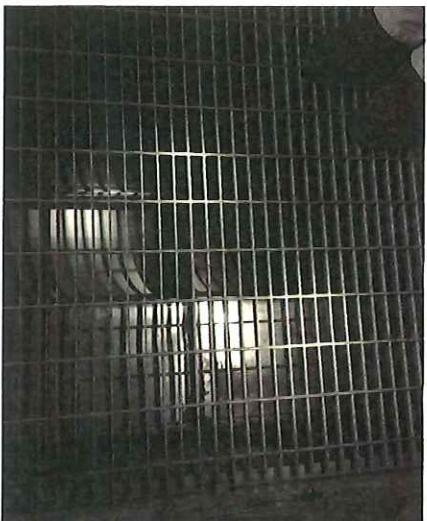
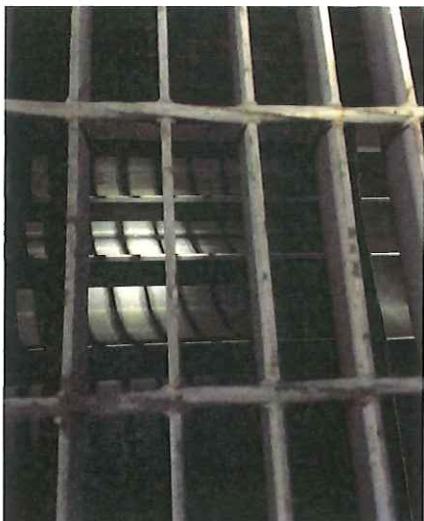
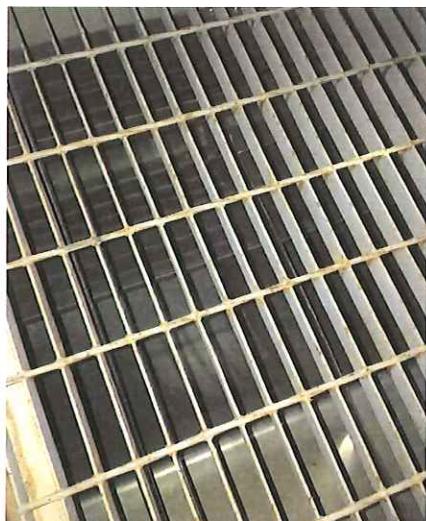
1. Reduced 31" at both ends of duct near sides of the unit (total reduction of 62").
 2. Reduced 20" from width of duct. (P3.4)
 3. New opening: 21" W x 213" = 31 FT2 → 3,219 FPM

4. Ducting takes an immediate 90° turn toward condensing section with turning vanes and sound attenuation. (P3.5 & 3.6)
 - a. Also found that shortly after discharge of the unit there is another 90° turn down and the duct splits into three separate ducts.

P3.4, 3.5, & 3.6: Supply Air Discharge Ducting Transition - Reduced Open Area, Turning Vanes, & Sound Attenuation

1. Correct the supply and return ducting to reduce the static pressure.
 - a. Determine return ducting design.
2. Rebalance the VAVs to operate at airflows that keep the supply fan in an operable condition.
 - a. Apply higher minimums and maximums airflow set points.
 - b. Create a total VAVs' airflow to coordinate directly with the speed of the supply fan.
3. Correct the isolation curbs missing center split support of the unit base.
4. Determine if they are correct and/or need there needs to be maintenance to the isolation curb's springs.
5. Correct supply fan #3's orientation to allow space for inlet flex connection to have a separation gap.
6. Correct supply fan #3's lack of isolation dampening.

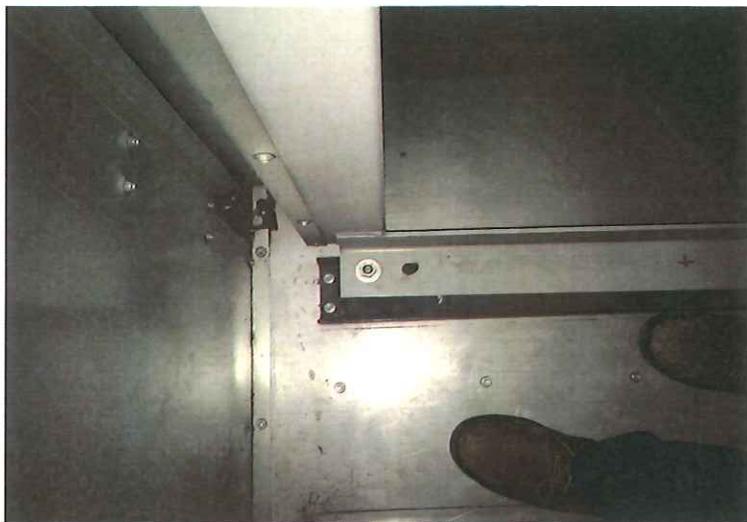
1. The motor was never repaired, and power never reconnected.
 - c. Supply Fan #3
 - i. Isolators are locked. There is no movement of the blower.
 - ii. Blower mounting rails appear to have been repositioned, and now the blower is not square to block-off wall (P4.1). There is about 1/8" gap of inlet flex on the right side (P4.3), but on the left side there is no gap, and the blower connection is touching the block-off connection (P4.2).

P4.1: Supply Fan #3 - Isolator Rail Reinstalled with Fan Off Square to Inlet Block-Off Wall

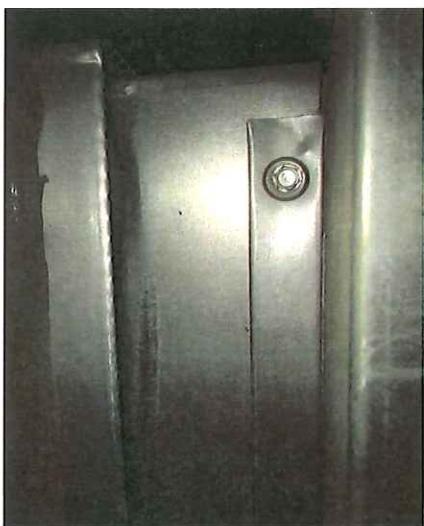
P4.2: Supply Fan #3 Inlet Flex Connection - Left - Impinged

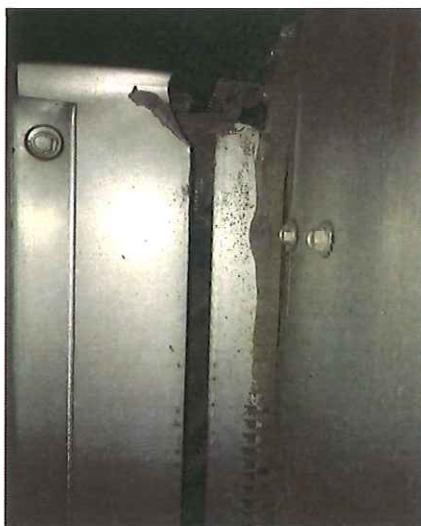
P4.3: Supply Fan #3 Inlet Flex Connection - Right - 1/8" Gap

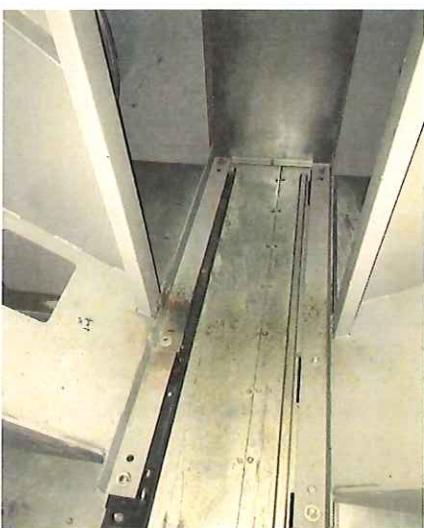
- iii. It appears that there was some repair done to SF# & SF#4 blower framing. It was stated that this had cracked and the welded an angle to repair. (P4.4)

P4.4: Supply Fan #3 Blower Rail Repair - Welded on Steel Angle
