Asbestos Abatement Work Plan for Floor Tiles and Mastic On Main Floor Visual Arts Building (2022) Casper College, Casper, Wyoming

FEI Project Number: AS21131

December 9, 2021

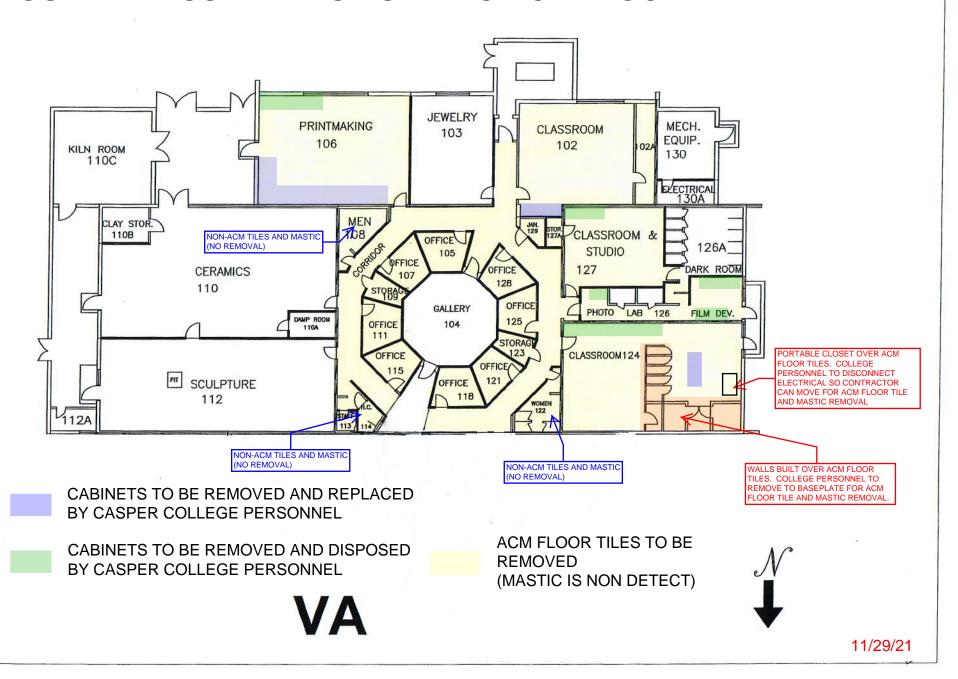
FIGURE 1 - VISUAL ARTS BUILDING ACM FLOOR ABATEMENT

Material Description	Material Location	Material Type	Friability	Asbestos Content	Approximate Quantity
Floor Tiles and Mastic	102, 102A, 105-107, 109, 111, 115, 118, 121, 122-129, and associated hallways (See Figure 1)	Miscellaneous	Non- Friable	6-8% Chrysotile in tiles ND in Floor Mastic and Cove Base Mastic	Approximately 7,821 sf See drawings and photographs

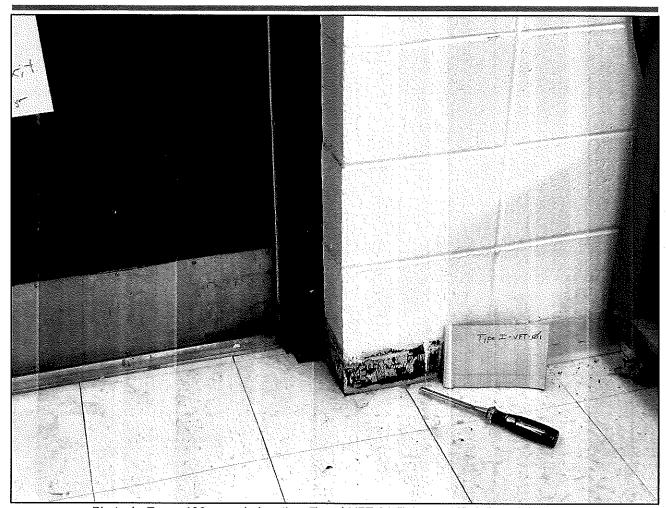
Photo 1. Room 106, sample location, Type I-VFT-01 (light tan 12"x12" vinyl floor tile).

Asbestos was detected at a concentration of 1.5% by point count in bulk sample, Type I-VFT-01, light tan 12"x12" vinyl floor tile, collected from Room 104, Weaving. The vinyl floor tile is in overall good condition throughout the building with some minor damage in isolated locations.
