# Casper College Campus Master Plan Refresh

+ hord | coplan | macht

### EXECUTIVE SUMMARY

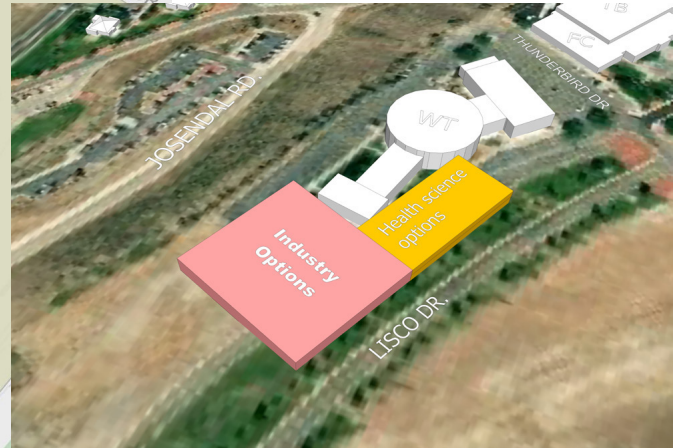
**Option 1 - South of existing Werner Tech**

Both options were well received with Option 2 allowing for adjacency to the existing Career Studies facility for interdisciplinary collaboration and better connection and visibility to Casper Mountain Road. Additionally, Option 2 maintains the current separation of the trades programs on campus, which the students enjoy. The final decision will need to be made when a Level I/II study is undertaken.

Construction costs for Option 1 are estimated at \$22.1 million, with a total project cost estimated at \$27.6 million. Option 2 is slightly less at an estimated \$20.7 million in construction costs, due to less anticipated sitework, with a total project cost of \$25.9 million.

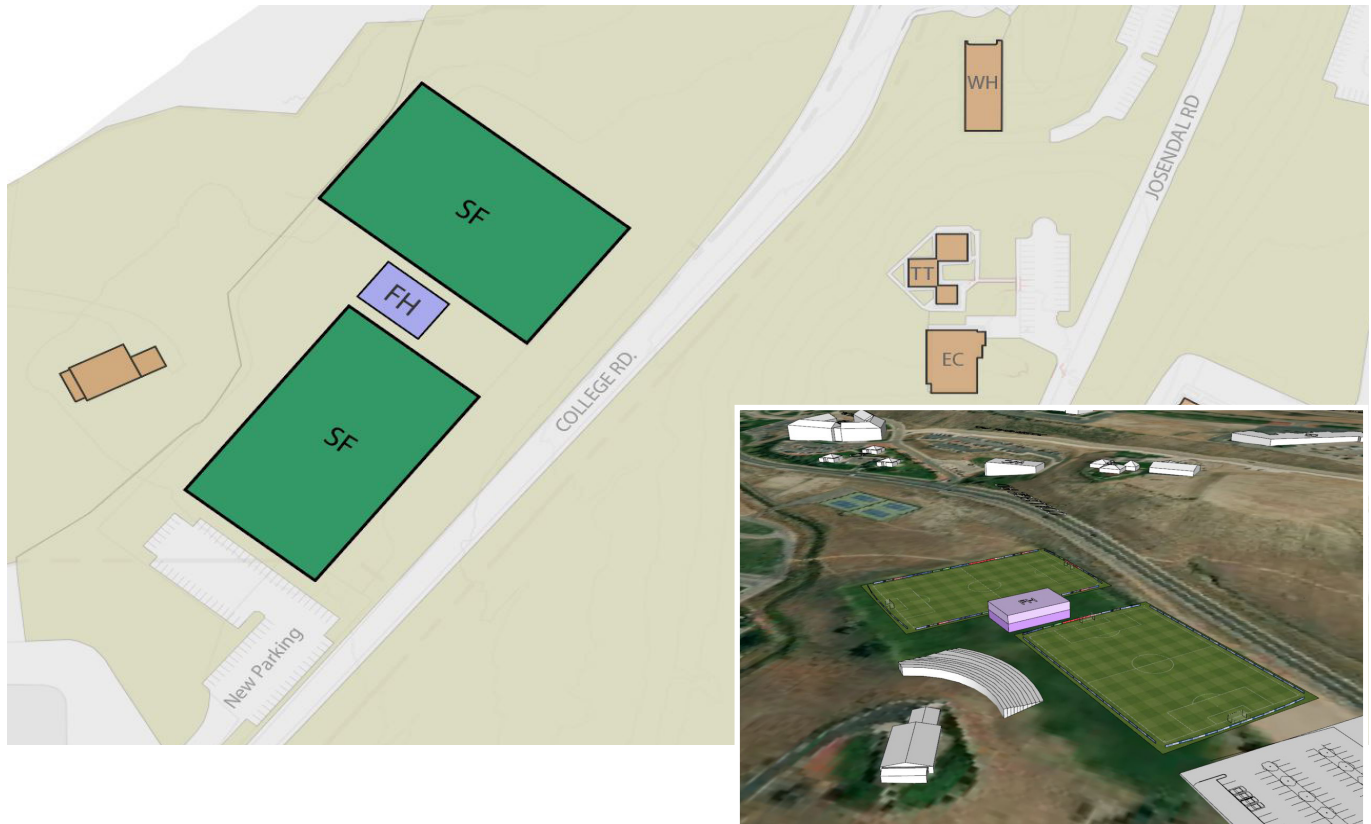
Two potential locations were tested for the proposed soccer complex. The first option is developing the existing Murane Field site with the desired amenities.

Construction costs are estimated at \$4.6 million, with total project costs estimated at \$6.6 million.

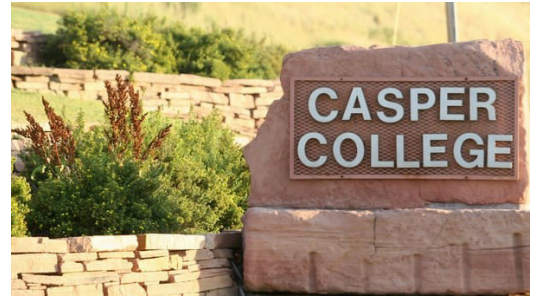
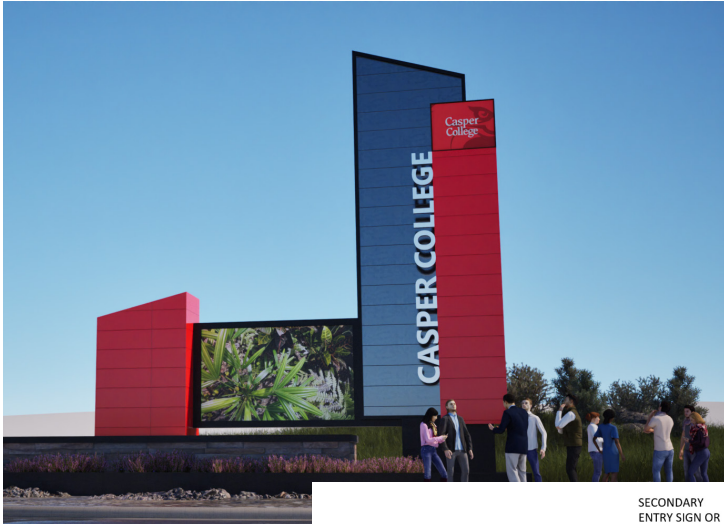
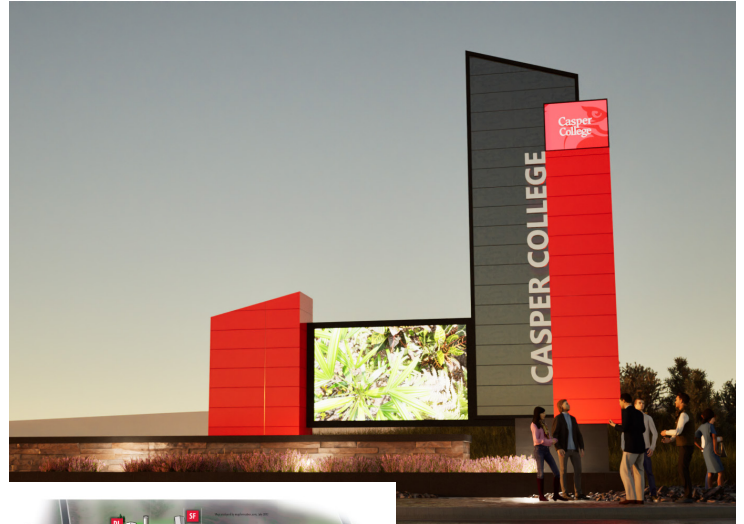
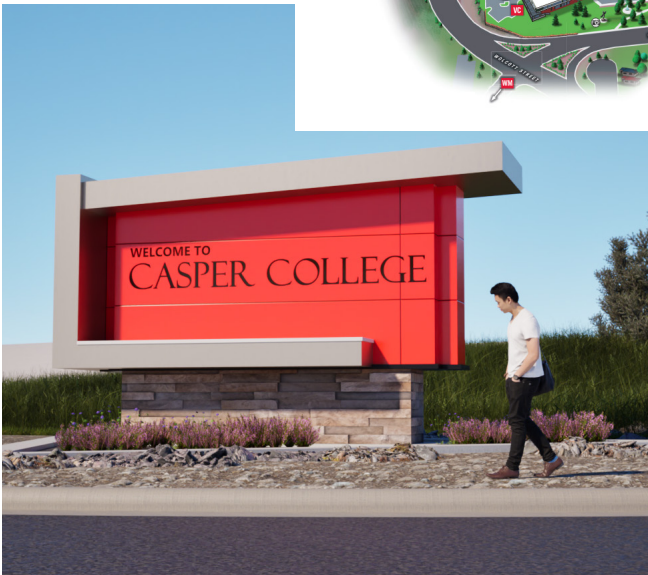
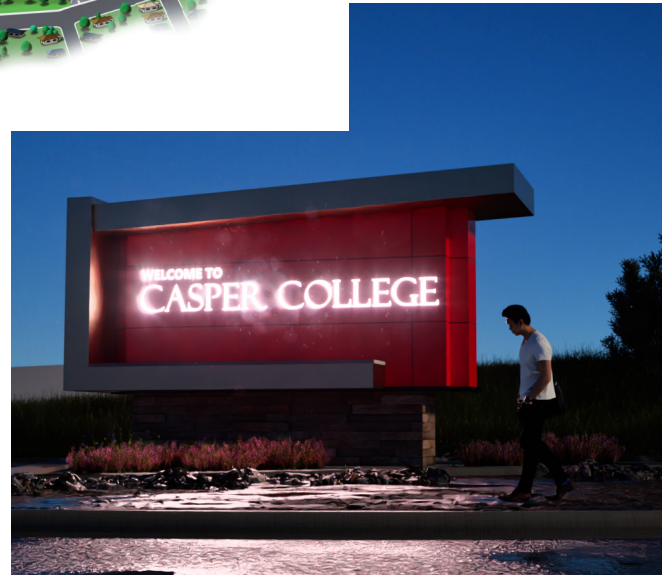
Casper College's current campus entry signage is undersized and dated. At less than five feet tall and just six feet across it is often difficult to see. Options for a more modern look and feel were developed that include LED visual display options that could be used to promote campus activities. Larger signage options would be posted at the main entrances with smaller scale signs posted at secondary entries. This will also alleviate any light pollution from the signs disturbing neighbors or students living in the dorms and apartments. Any lights used on the secondary entries will be designed to light the sign and not the surrounding areas. Anticipated costs for smaller signs is approximately \$100,000, larger signage is anticipated to be between \$225,000 and \$250,000, per sign.

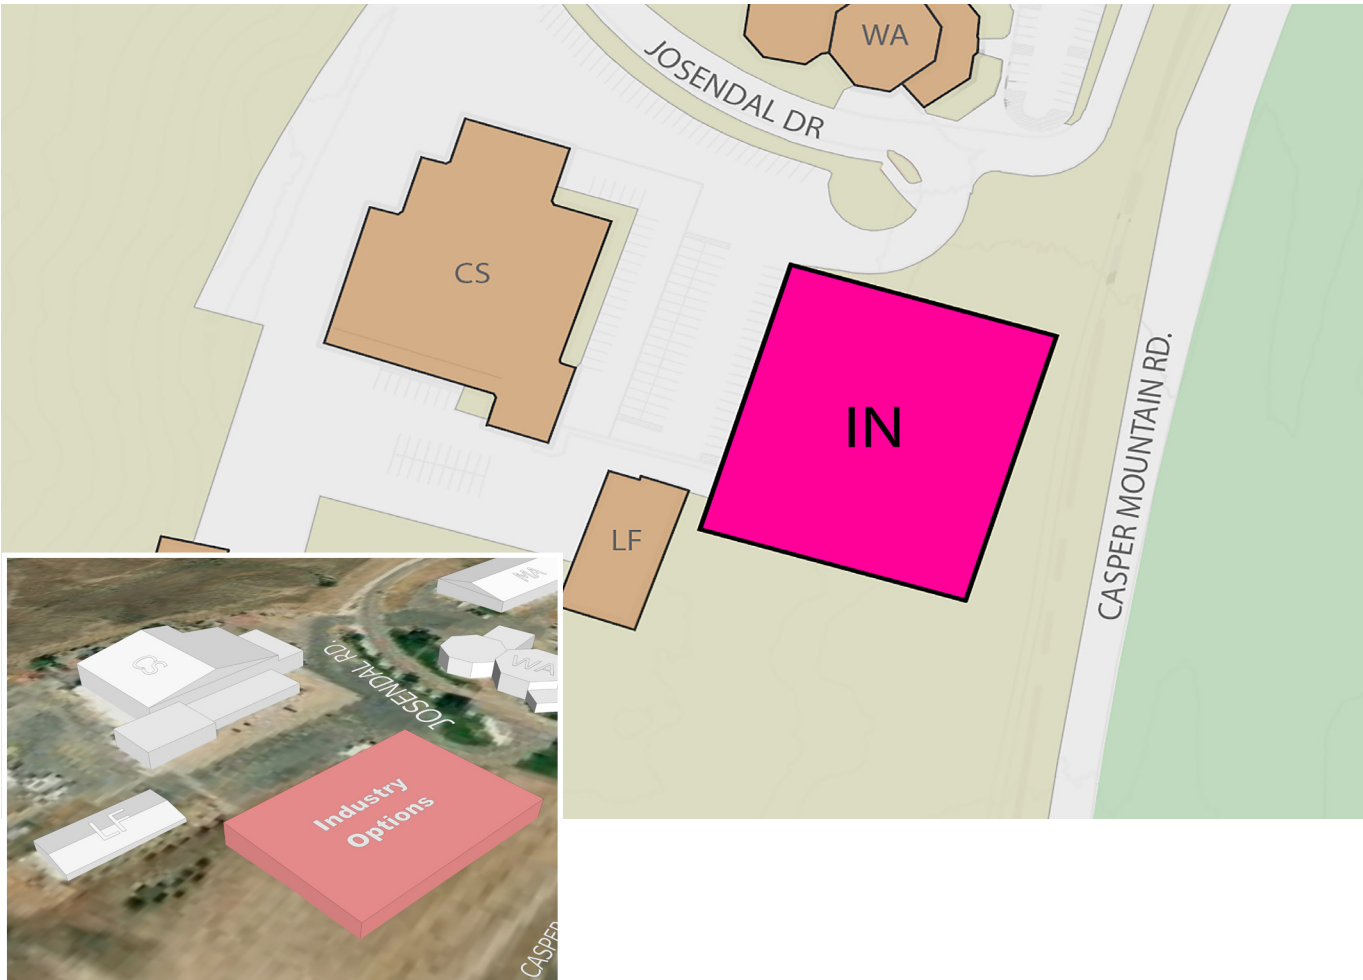
Industry Option 02 Massing & Site Diagram

- i. Less visibility to the building location from the rest of campus and the public, although it would have some visibility from Casper Mountain Road. To optimize visibility signage could be provided which has display opportunities to advertise programs in the building.
- ii. Maintains disconnect between north and south side of campus, especially once Werner Tech is demolished leaving a larger gap between the two sides of campus.
- iii. Constrained site, so there is little room for growth for future programs.

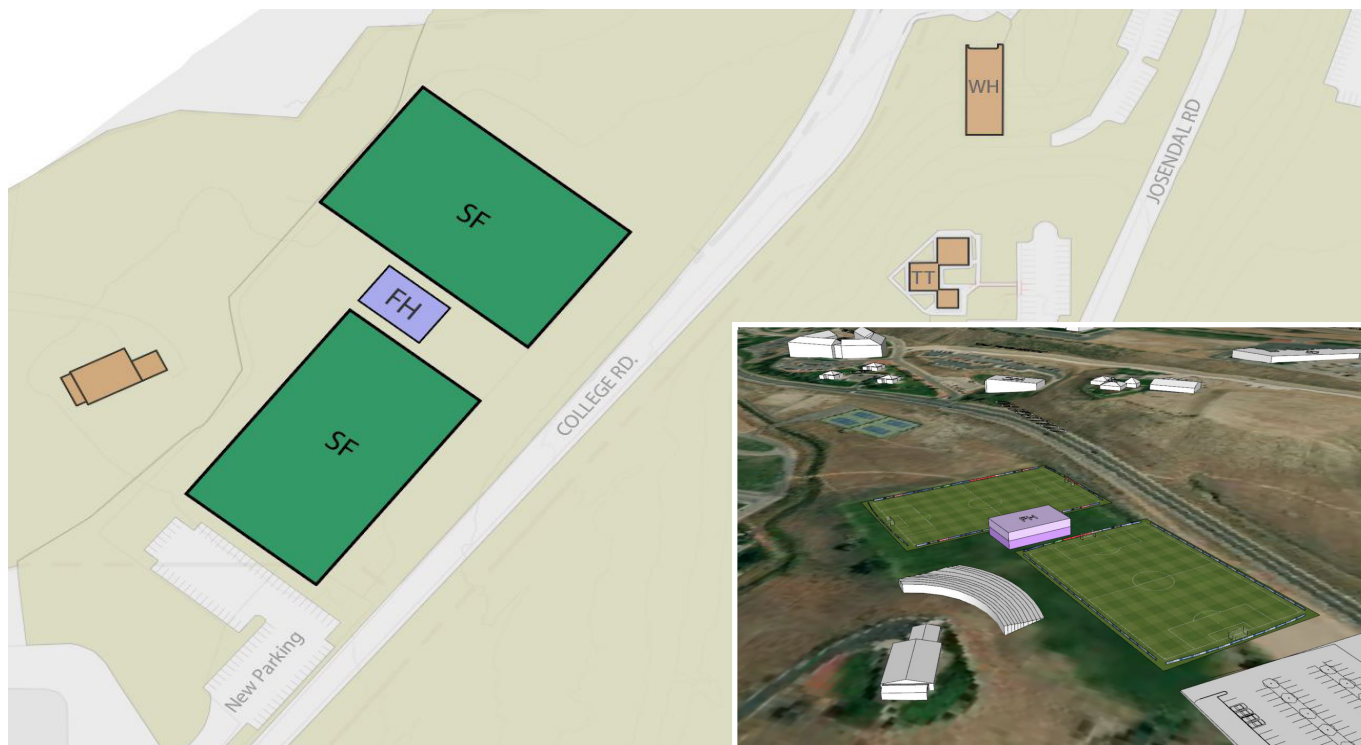
### Soccer Field Option 01 - Aerial View Looking Toward Campus and Site Diagram

- i. Proximity to Thunderbird Gym is ideal for athletes to use existing locker rooms and keeps the athletic programs connected. Better utilization of the existing facility.
- ii. Integrated into the campus
- iii. Existing parking can support soccer game visitors rather than building a new parking lot at Murane Field

- i. Not adequate room for both a collegiate sized field and the practice field, so the practice field would remain at Murane Field
- ii. Losing land that could be used for future facilities
- iii. Werner Tech facility has to be demolished for this option to work
- iv. Potentially a windier location

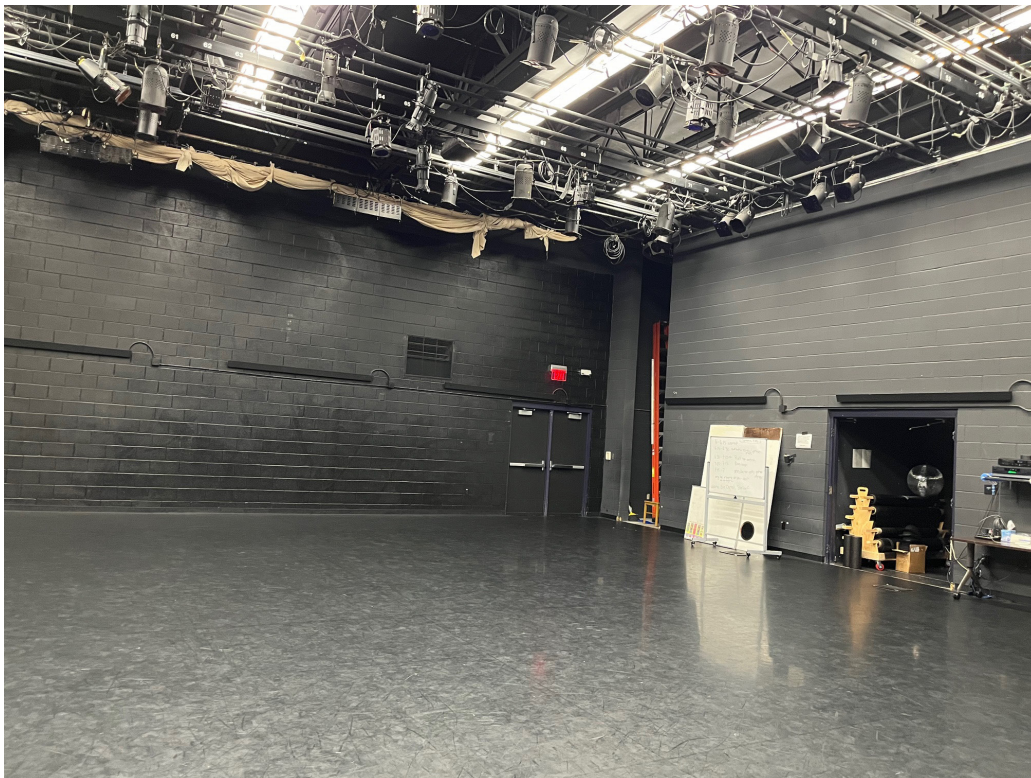
**Dance Studio KT-159:** floor is buckling and needs to be replaced. The buckling is a safety concern for the dancers. Consistent moisture problems have led to issues with mold and will continue to lead to buckling of the dance floor. Not only is this a tripping hazard, an unsafe amount of moisture is constantly collecting in electrical boxes in the floor. Mold, electrical issues, and buckling will continue until the moisture issue is solved. The first item that needs to be addressed is the moisture intrusion. The moisture issue primarily occurs during warmer temperatures. The area is known to have high ground water due to an existing spring in the area. The exact cause needs to be determined to provide a solution and a cost. Once the water is no longer creating issues, the flooring may or may not need to be replaced.

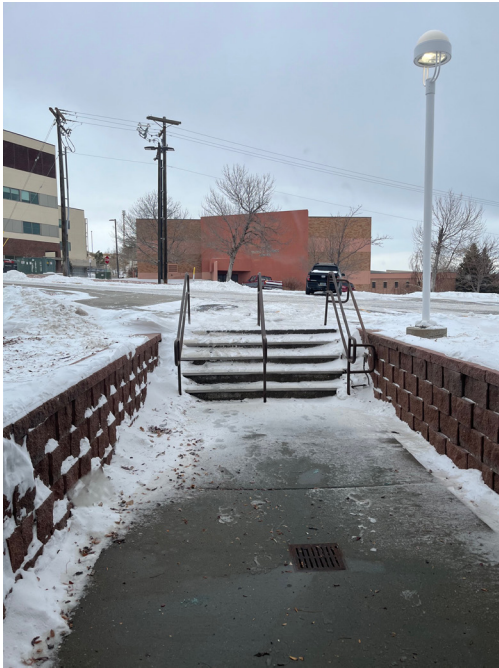
Southwest Entry

**Exterior Safety Issues:** The southwest entrance steps near Office KT-156 builds up with snow and ice and remains that way for long periods of time. This entrance is frequently utilized by faculty and dance students. An addition would be costly, but would eliminate the exterior stairs and make them interior instead. Another exterior safety issue that was identified by staff are the stairs to the overflow parking in winter. The snow drifts over the stairs in the winter. With the direction and ferocity of the prevailing winds, there is not an easy solution to this issue.

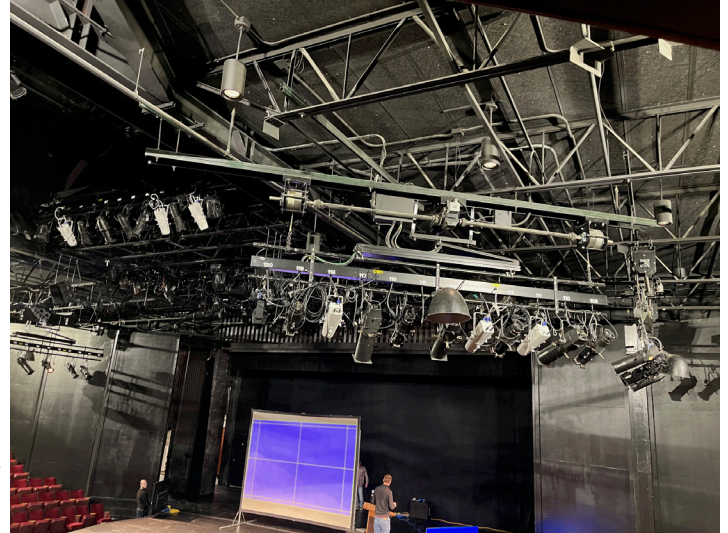
**Grid System:** The grid system is unsafe and lacks a complete harnessing system to protect students in case of a fall. The department has to use a Genie lift to replace bulbs and move lights instead of using the grid system. The refocusing of lighting instruments for each production should be a simple task, but instead takes days to complete. The performance lighting is so outdated, that replacement bulbs are difficult if not impossible to obtain. Staff and faculty have been utilizing other lights to set for production needs which in turn create tripping hazards. The lighting system currently being used is pasted together from several sources and generations of lighting technology and dimmers. Newer color changing LED lighting technology reduces ongoing costs and gives students experience with technology that they will actually use in the field.

This needs to be updated to the current industry standards to ensure educational integrity of the Theatre Tech degree. The design team would suggest upgraded performance lighting that can be raised and lowered for safety and ease of use. The lighting controls board and dimmer racks should also be replaced.

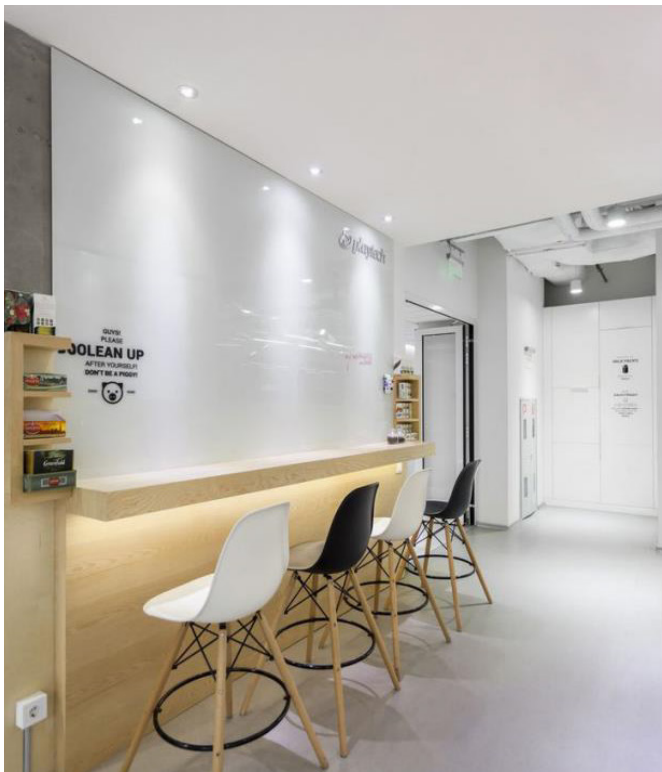
Existing corridor is not inviting and dark.

**DAYLIGHT:** Different finishes and break out spaces could make the corridors feel more inviting.

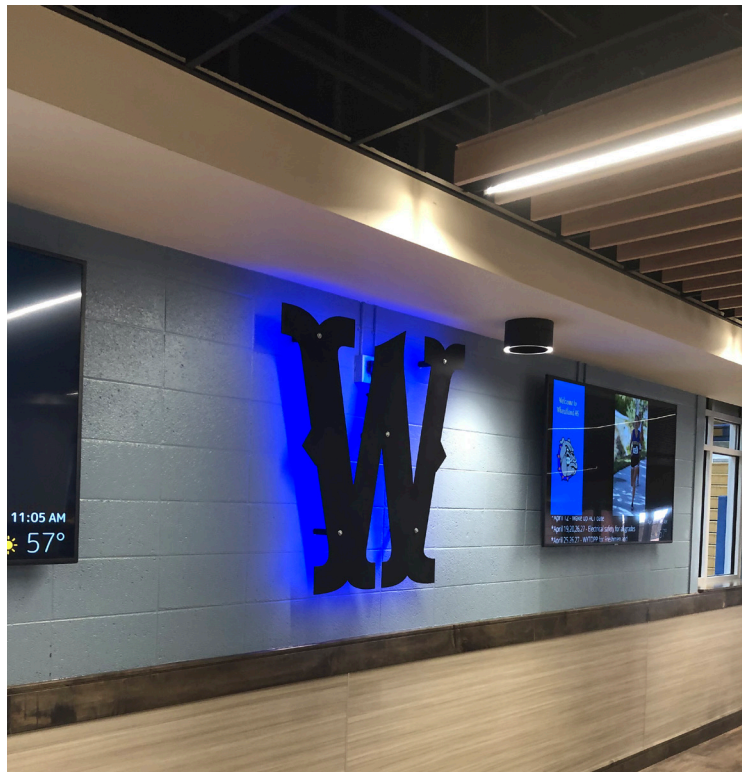
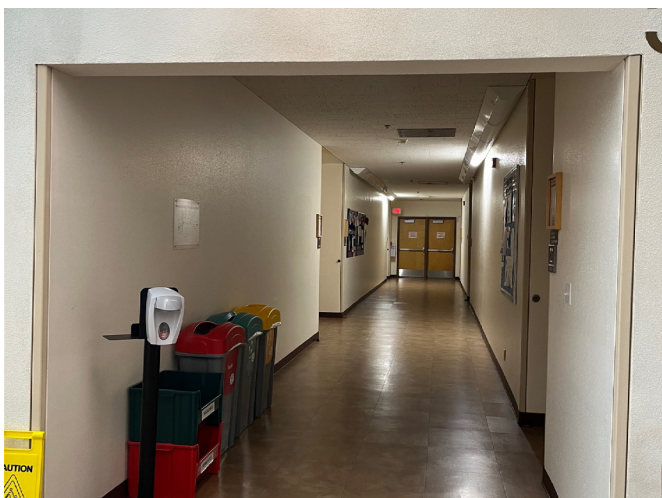
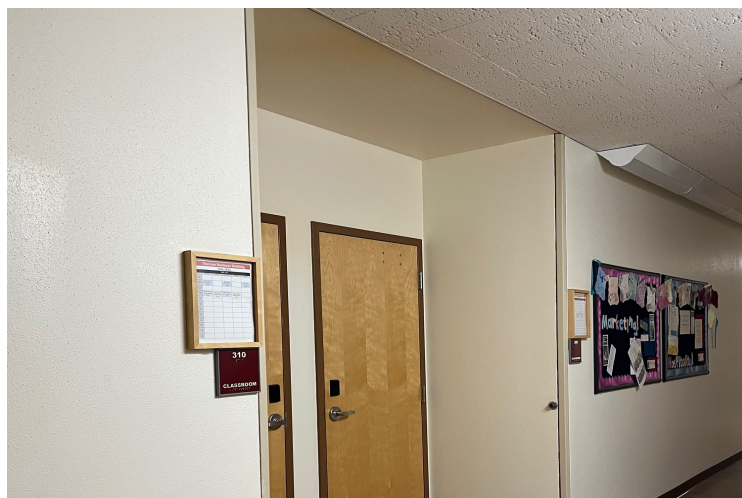
Ceilings are at 9'-0" so transoms could be added above doors to share light. Ceiling grids could be removed to add more height and interest to the space.

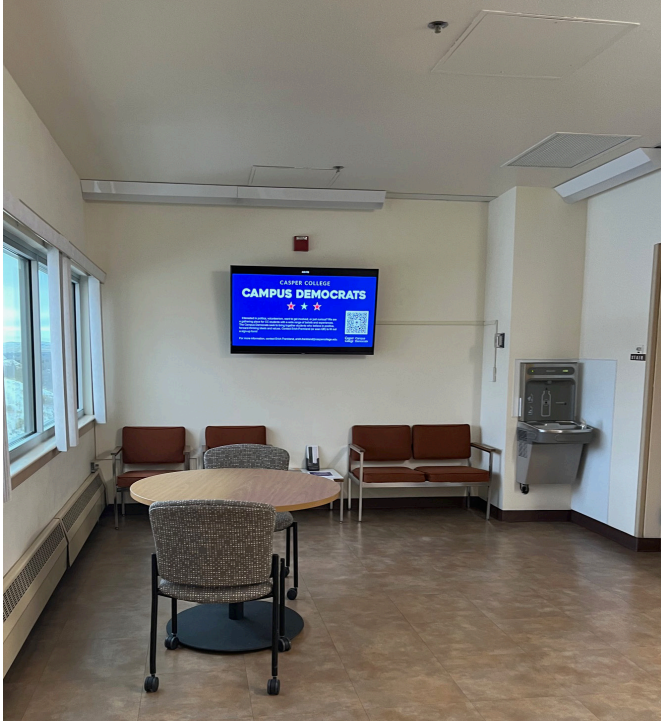
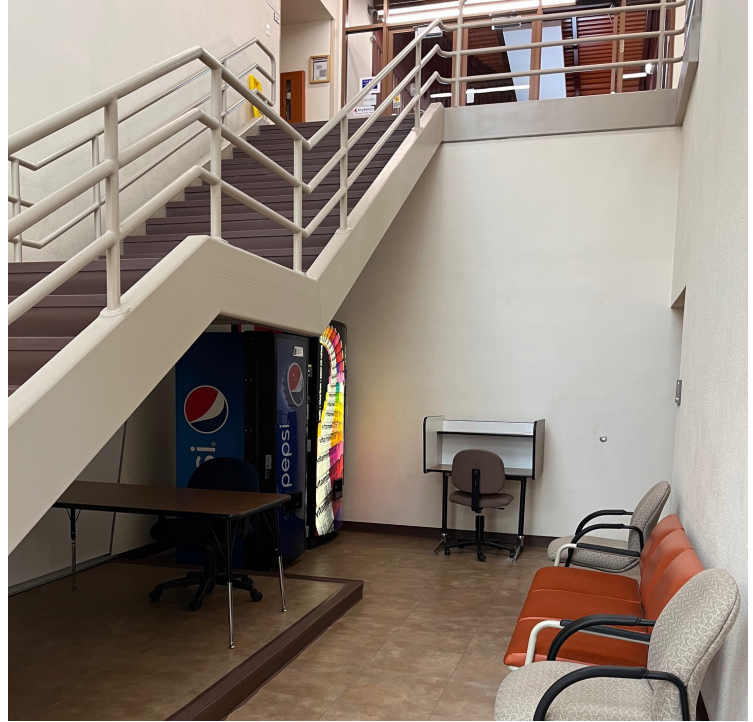
Existing pockets of space where students can gather, collaborate and study.

Add soft, inviting furniture that can easily be rearranged - provide pods for individual or group study.

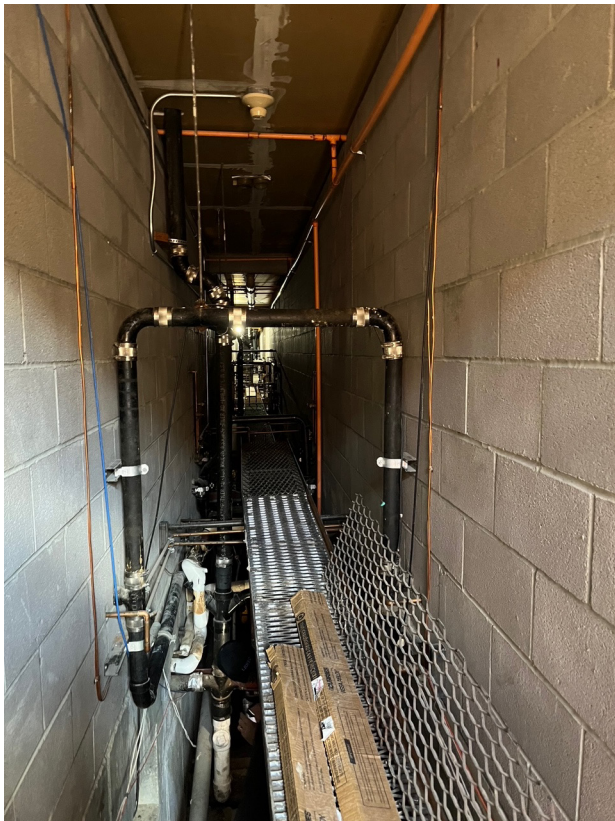
**PIPE CHASE:** The existing pipe chase is extremely unsafe for maintenance personnel. It is poorly lit, the pathways to service the piping are narrow, rickety and wobbly. This access does not comply with OSHA requirements. There are no cost effective ways to make the space OSHA compliant.

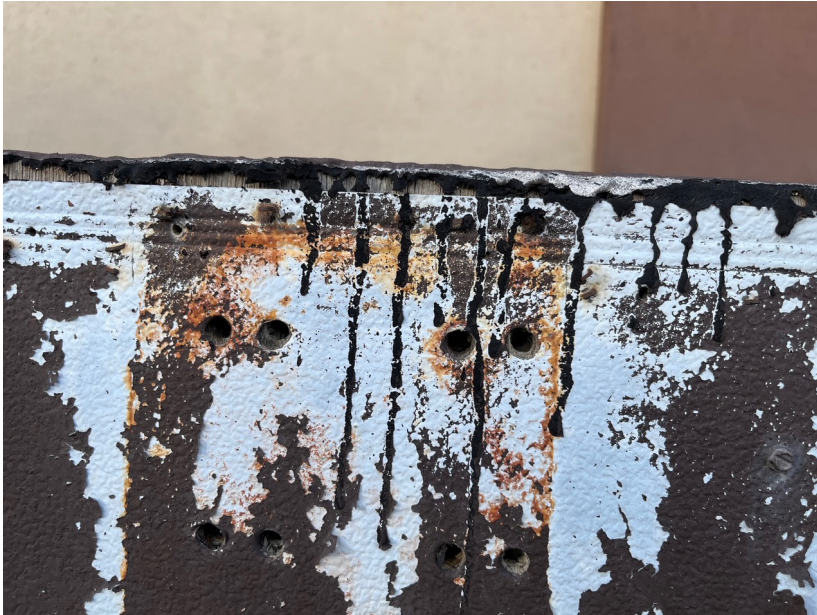
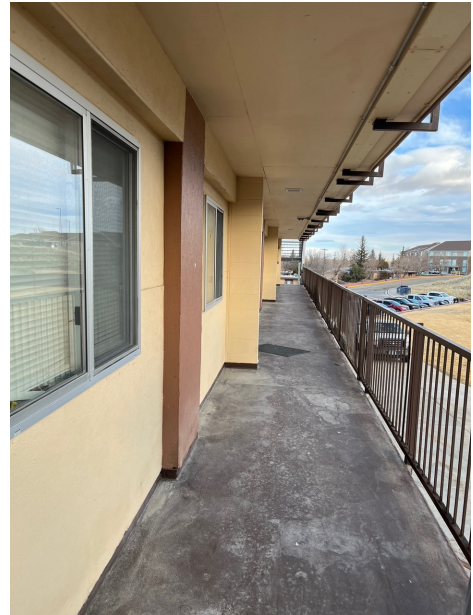
**EXTERIOR BALCONY:** The exterior balconies are an ongoing maintenance problem. The structural report has noted that they are in serviceable condition at this time. The new railing project left exposed holes in the fascia that were never sealed. Water has infiltrated the holes and has started to make the wood warp and swell. The wood framed walkways are very vulnerable to deterioration and the coating applied makes it difficult to determine any issues. The metal fascia is rusted and the paint has started to peel. The railings were replaced in 2000 and are performing well structurally, but need to be repainted. Destructive testing could be used to determine condition of wood under coating.

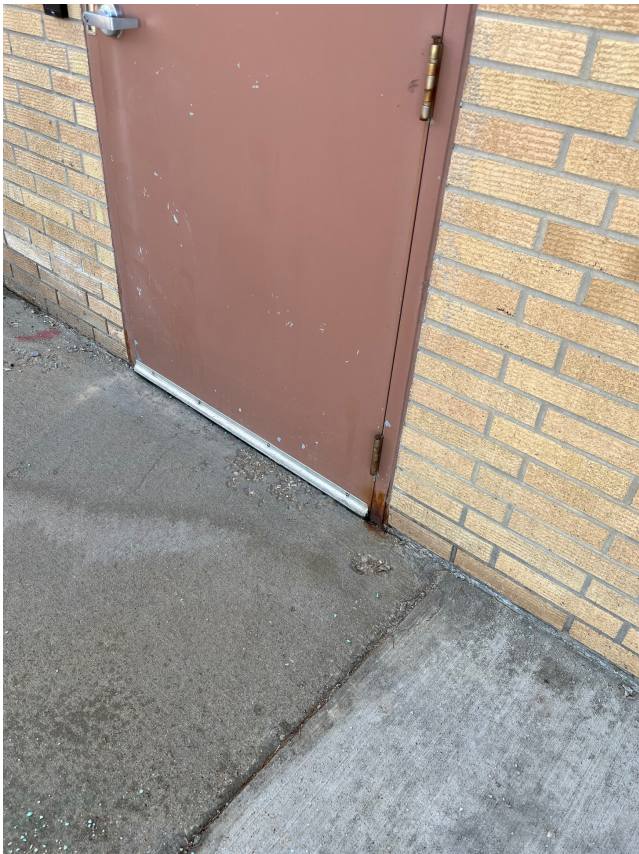
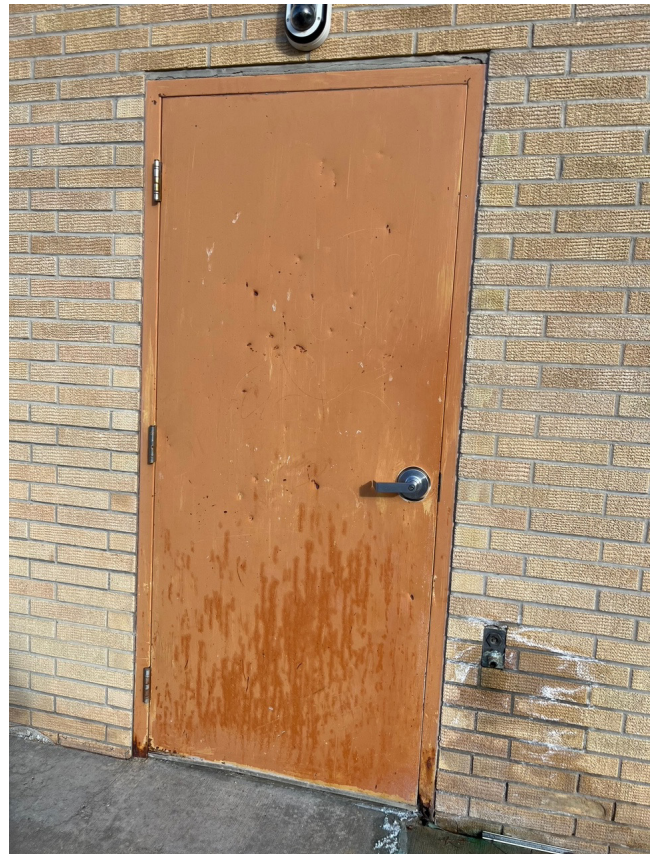
**EXTERIOR DOORS:** Replace the exterior hollow metal doors and frames into the mechanical spaces. They are dented and rusted.

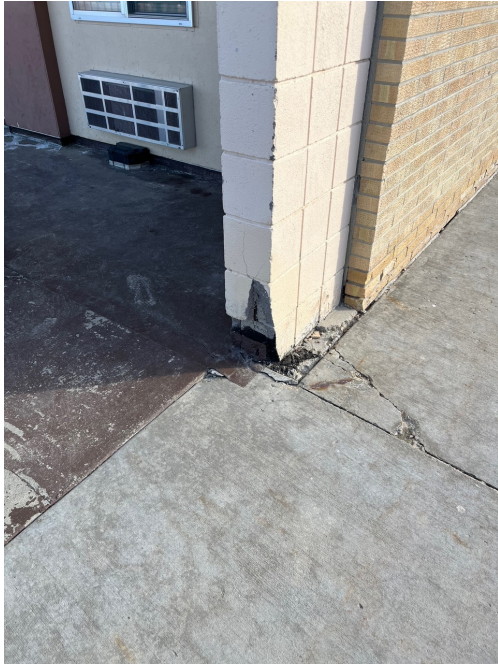
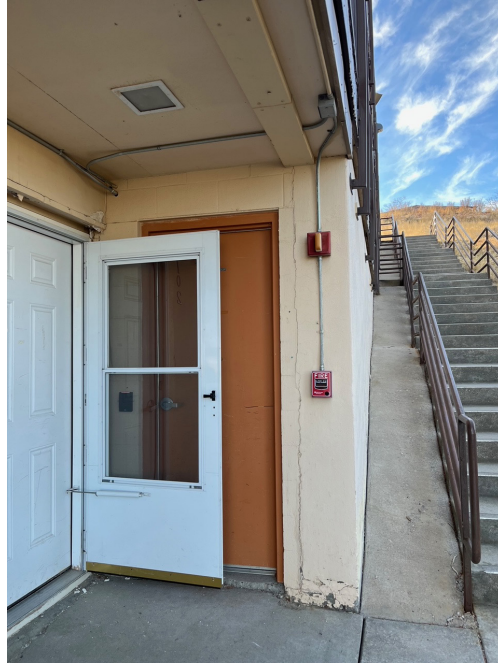
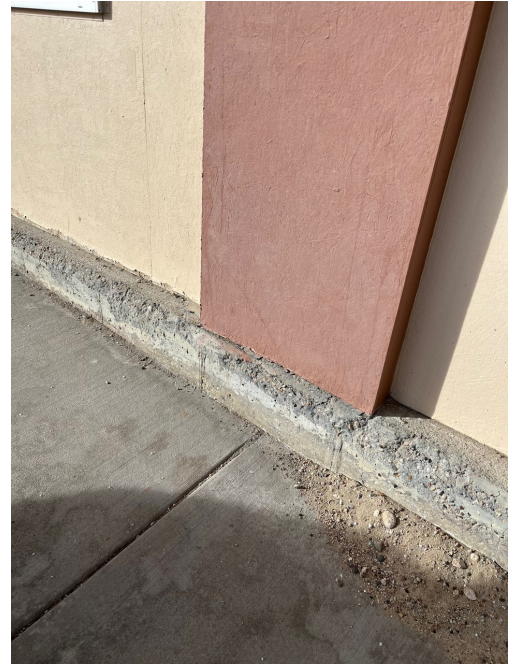
**EXTERIOR AESTHETICS:** The old redwood plywood has been replaced with OSB siding over the years. It was never meant to be a finished exterior surface. No flashing has been provided at the exterior foundation which has allowed water over the years to infiltrate and damage the concrete, brick, CMU, and siding. Paint is peeling and overall the exterior is in a state of disrepair. The finishes have exceeded their service life.

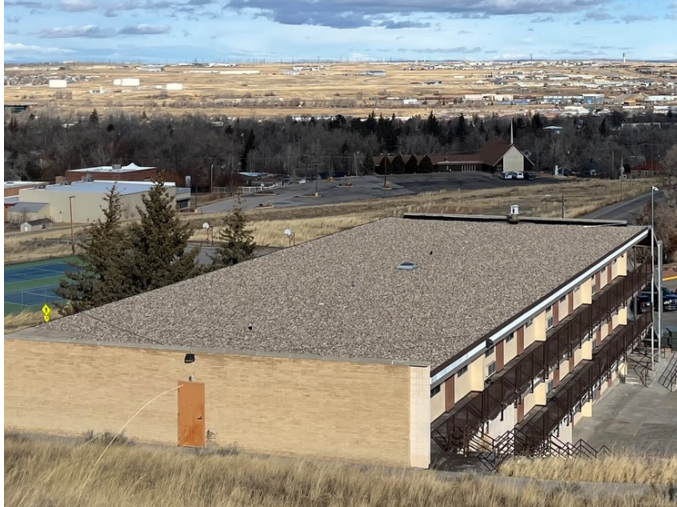
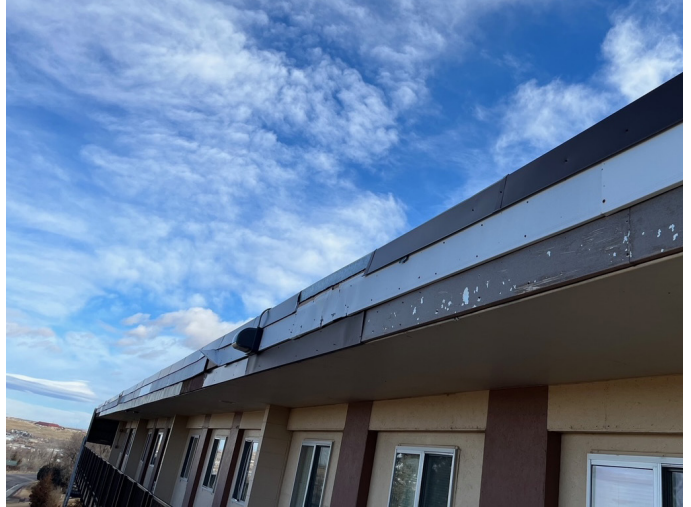
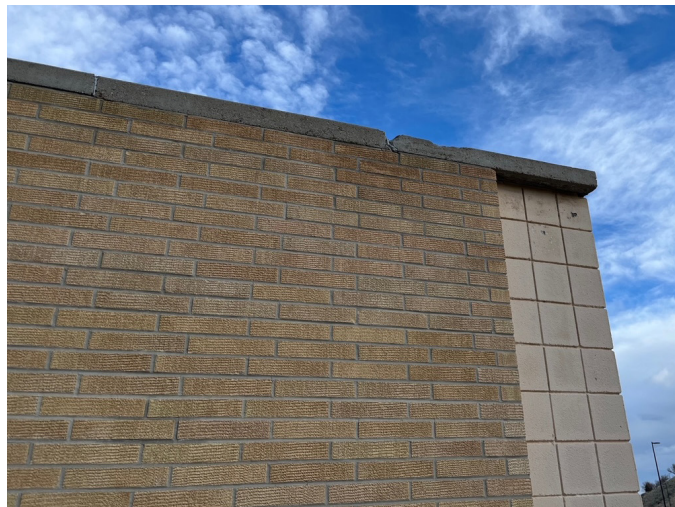
**ROOF:** The roof cap is falling apart. The roof fascia is mismatched and has partially blown off the building leaving exposed wood. The existing roof is a ballasted EPDM system. It is performing well, but is no longer under warranty.

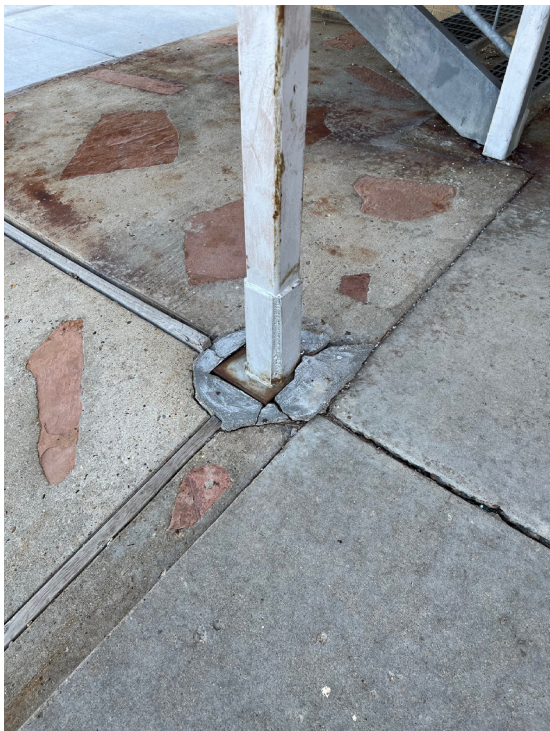
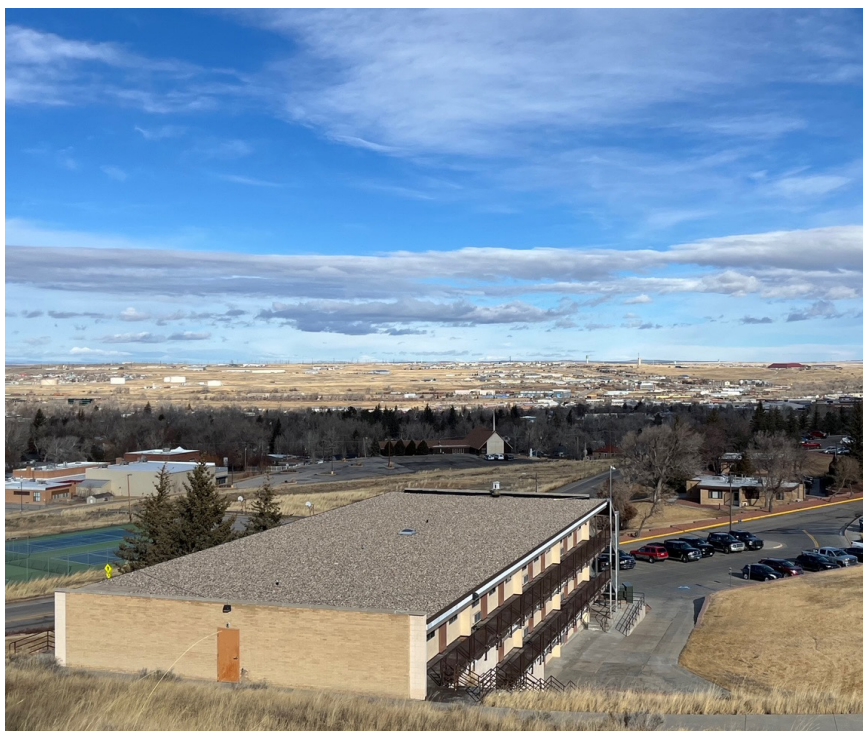
**DRAINAGE:** The drainage around the site has cause issues with the concrete and building materials. Part of the issue is the sidewalks do not slope away from the building. The other issue is it is built in a hole and water comes off the mountain into the building causing concrete to crack and spall. The pipe chase has water in it in the spring time from the site.

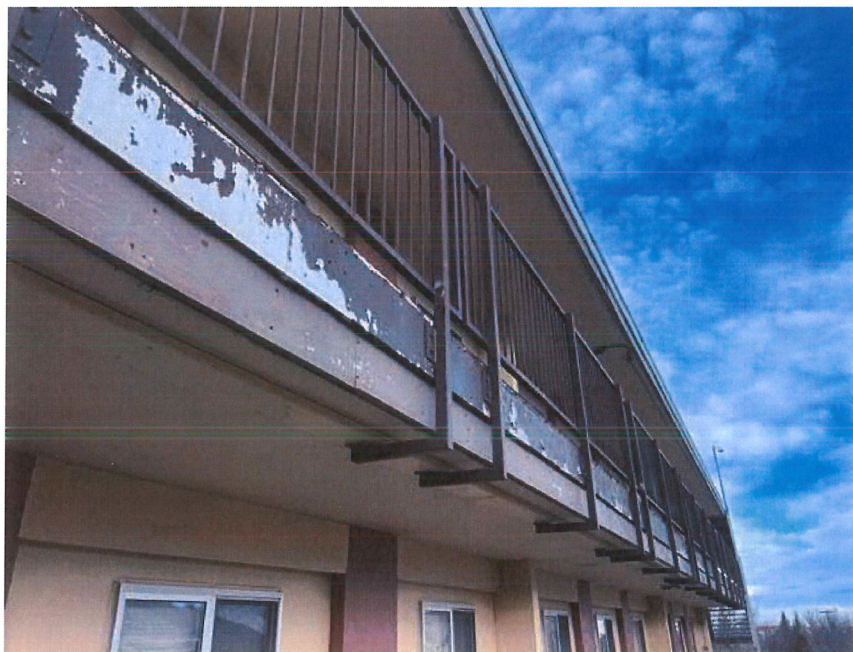
I am aware of two retrofit projects that our office completed on the building in the past. In 1999 we replaced the existing steel framed exit stair towers on the north end of the building. The new towers are performing well. In 2000 we replaced the walkway handrails of the second and third floors. The new handrails are performing well. (Photo-1).

Photo-1: Walkway Handrails.

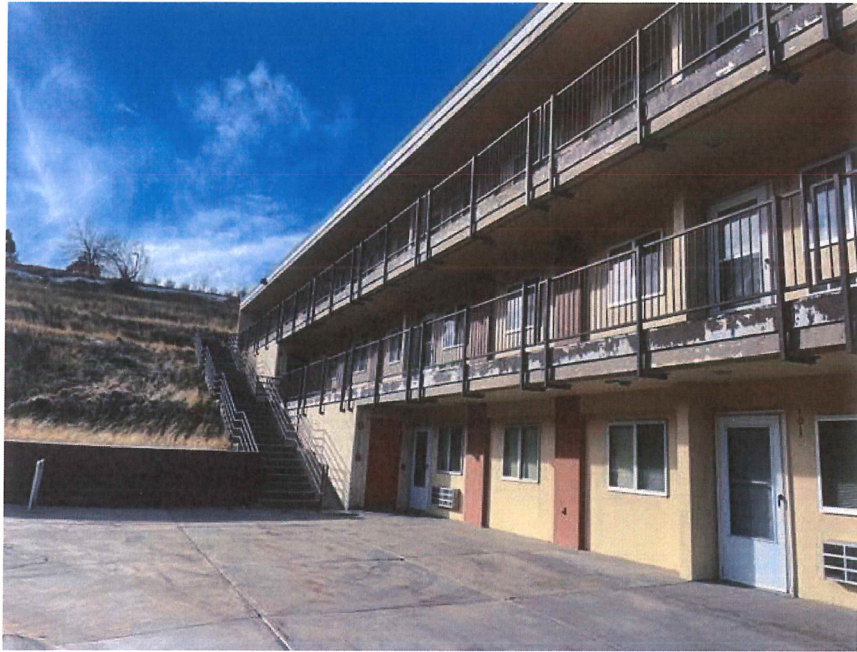
The walkways at the second and third floors are formed by the cantilevered wood chord / steel web floor joists. The wood framed walkways are very vulnerable to deterioration and require constant maintenance. The walkways are in serviceable condition at this time. (Photo-2).

Photo-2: Exterior walkways at second and third floors.

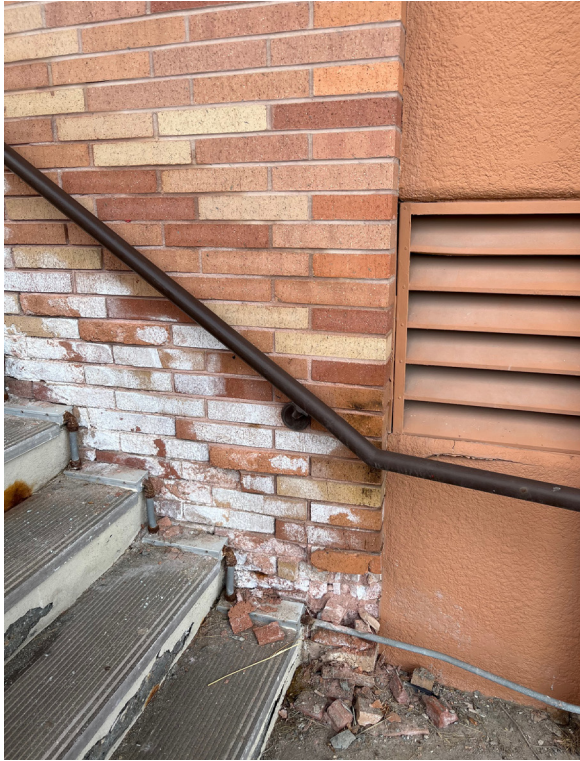
**EXTERIOR ENTRY:** The exterior stairs on the northside are deteriorating and are a tripping hazard. They are exposed to the exterior elements and become extremely icy in the winter. They need to be replaced. The stairs provide the primary emergency egress from the first floor of the building. Damaged brick by the stairs needs to be removed, replaced and repointed as well. One option to prevent further deterioration after they are replaced is to enclose the entire entry. This would also eliminate the maintenance during the winter and prevent slipping hazards on the stairs. This does not address the issue of a lack of accessible entry on the northside of the building. Handicap students or faculty would still have to enter at the southside entry and park above.

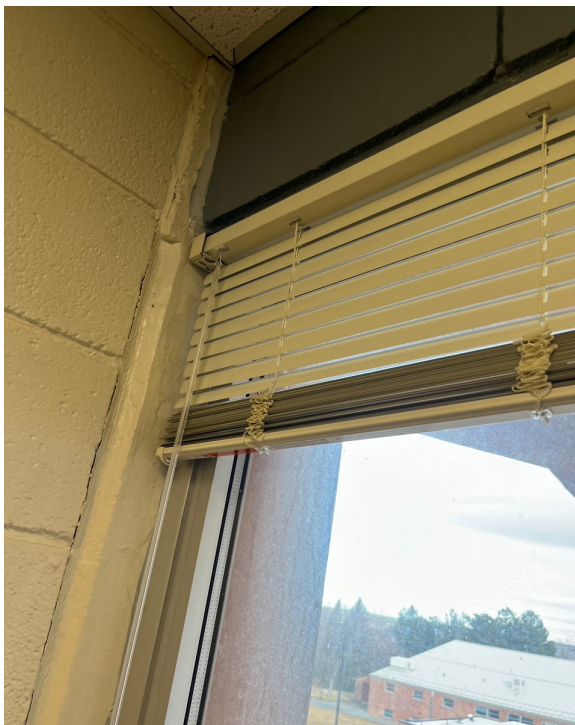
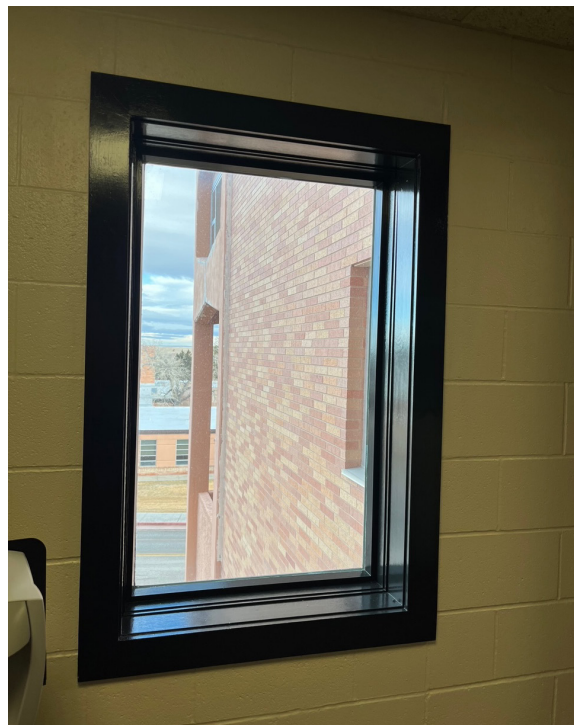
**EXTERIOR WINDOWS:** Replace exterior windows that leak with new thermally broken aluminum storefront insulated windows for energy efficiency and to prevent further damage to the walls.

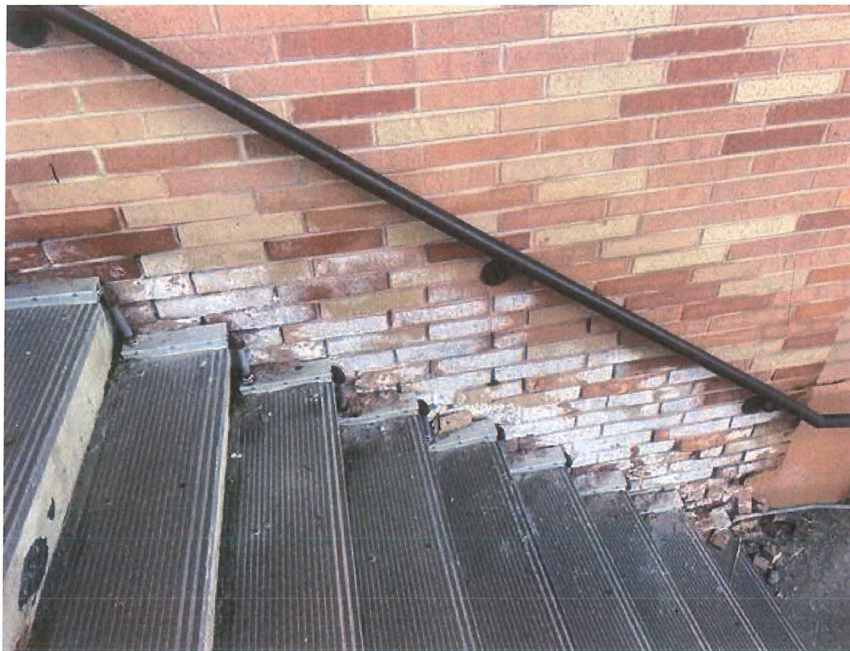
Photo-3: Damaged exterior stairway and brick at north-west.

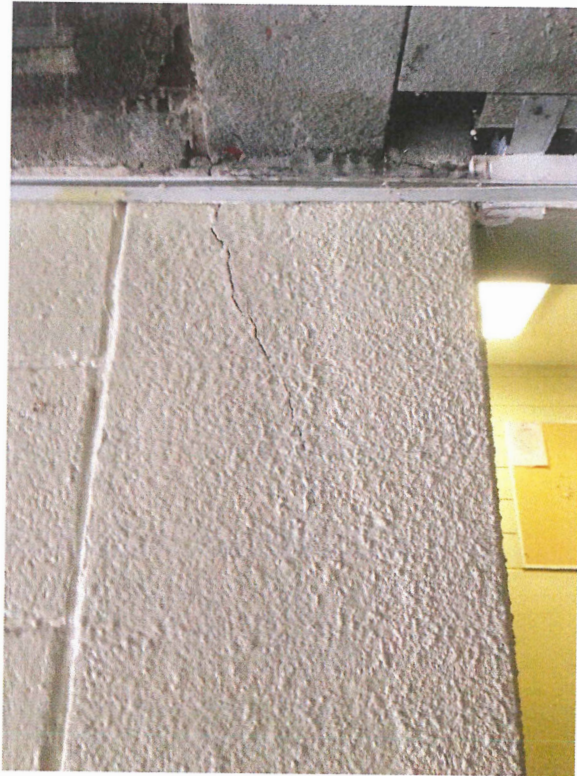
Damaged beam bearing

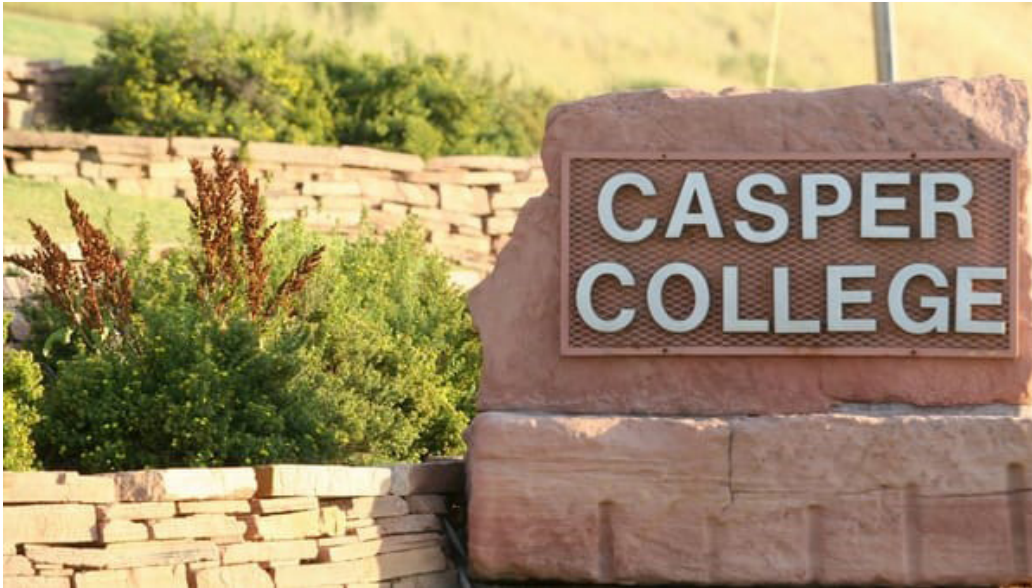
The current signage fits within the overall aesthetic for the campus, but several of the signs are difficult to see from the road because of the topography of the campus as well as the scale of the signs. The existing entry signs are also in need of repair and are inconsistent with the new campus color palette, font, and logo.

We would recommend replacing the existing entry signage with a sign that is larger and has a taller vertical component to increase visibility and massing at the main entries. These signs could have a digital display component conveying upcoming events, and other pertinent information. The signs would have more public outreach as the College would be able to advertise events on campus to those that do not find themselves at Casper College for other reasons. The new signage would also be lit up at night to help with visibility at the entry points. The signs could have different logos to differentiate the area of campus like the Thunderbird for the entry that goes towards the gymnasium. A sign base with dry stacked flagstone or CMU would maintain the overall campus aesthetic. Using the campus color and logos from the Casper College brand standards would also help support a cohesive message for the campus starting from the entry.
