# Casper College Campus Master Plan Refresh

+ hord | coplan | macht

### EXECUTIVE SUMMARY

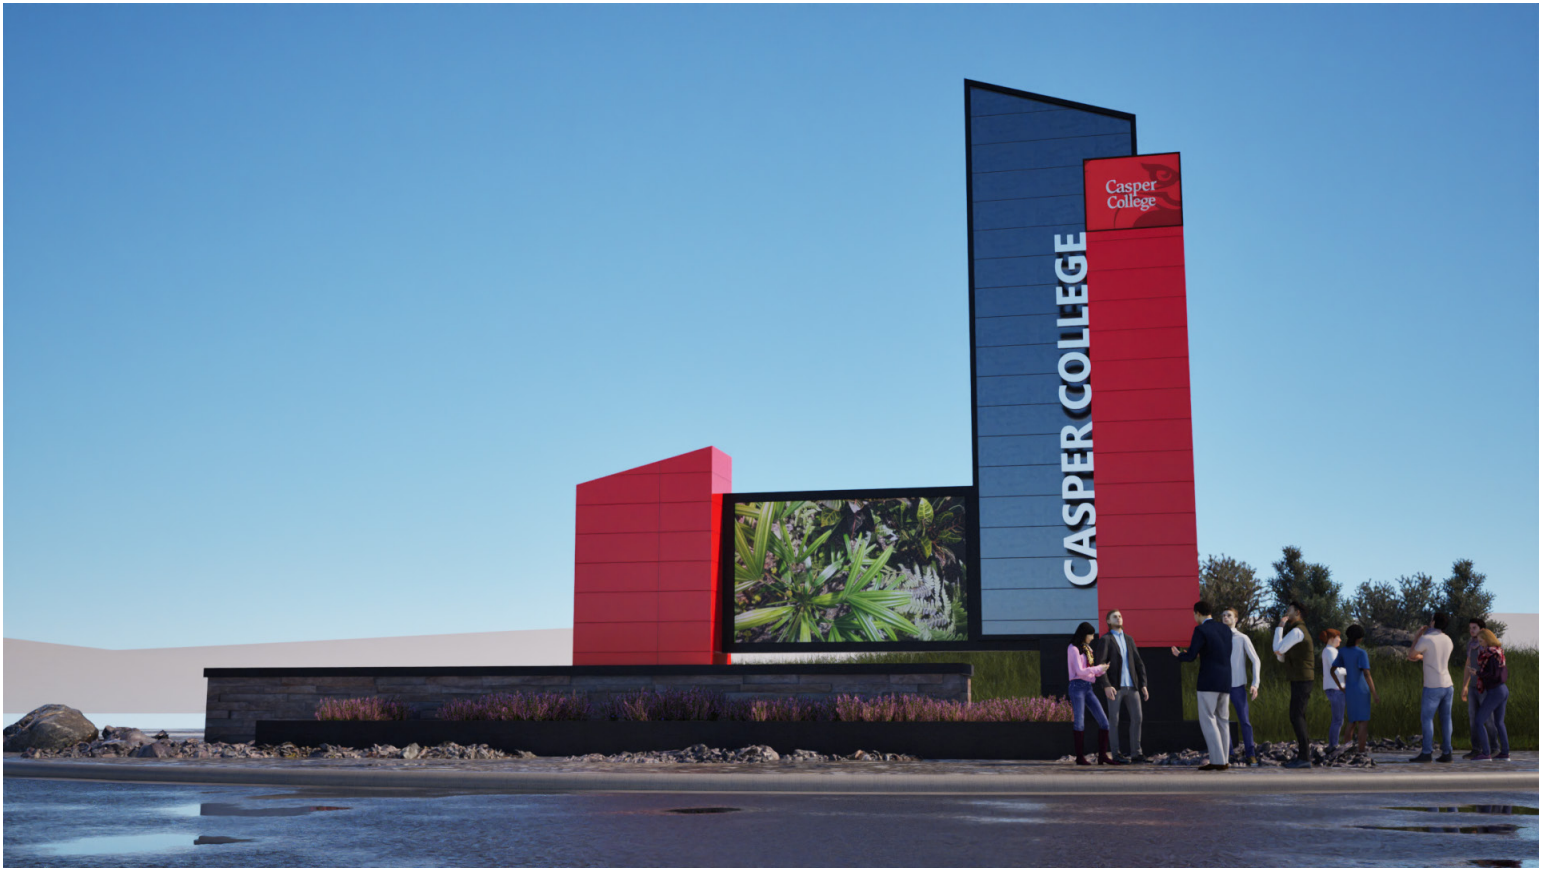
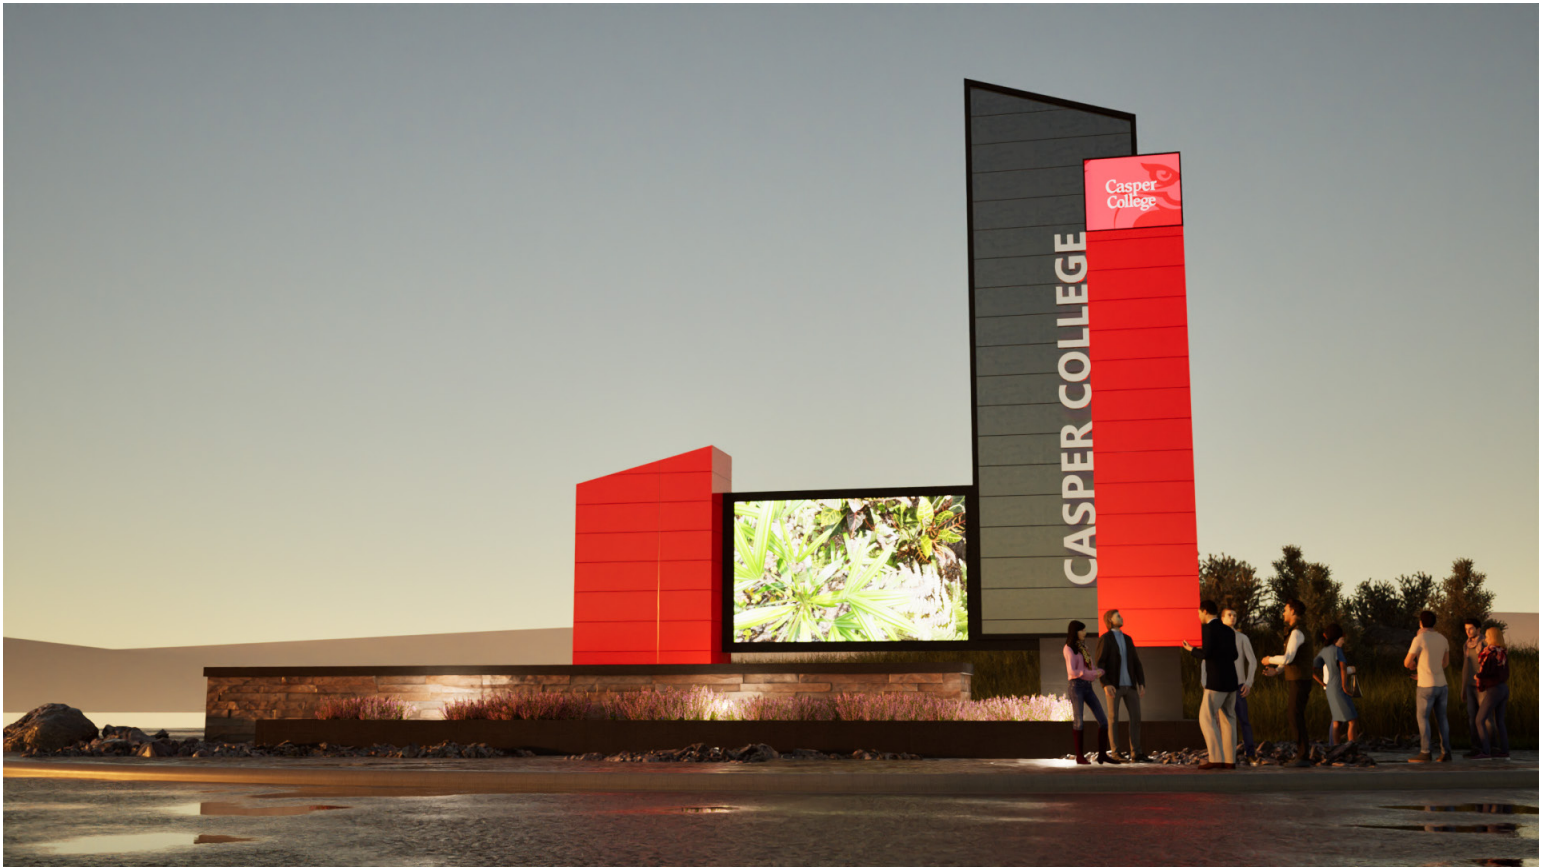
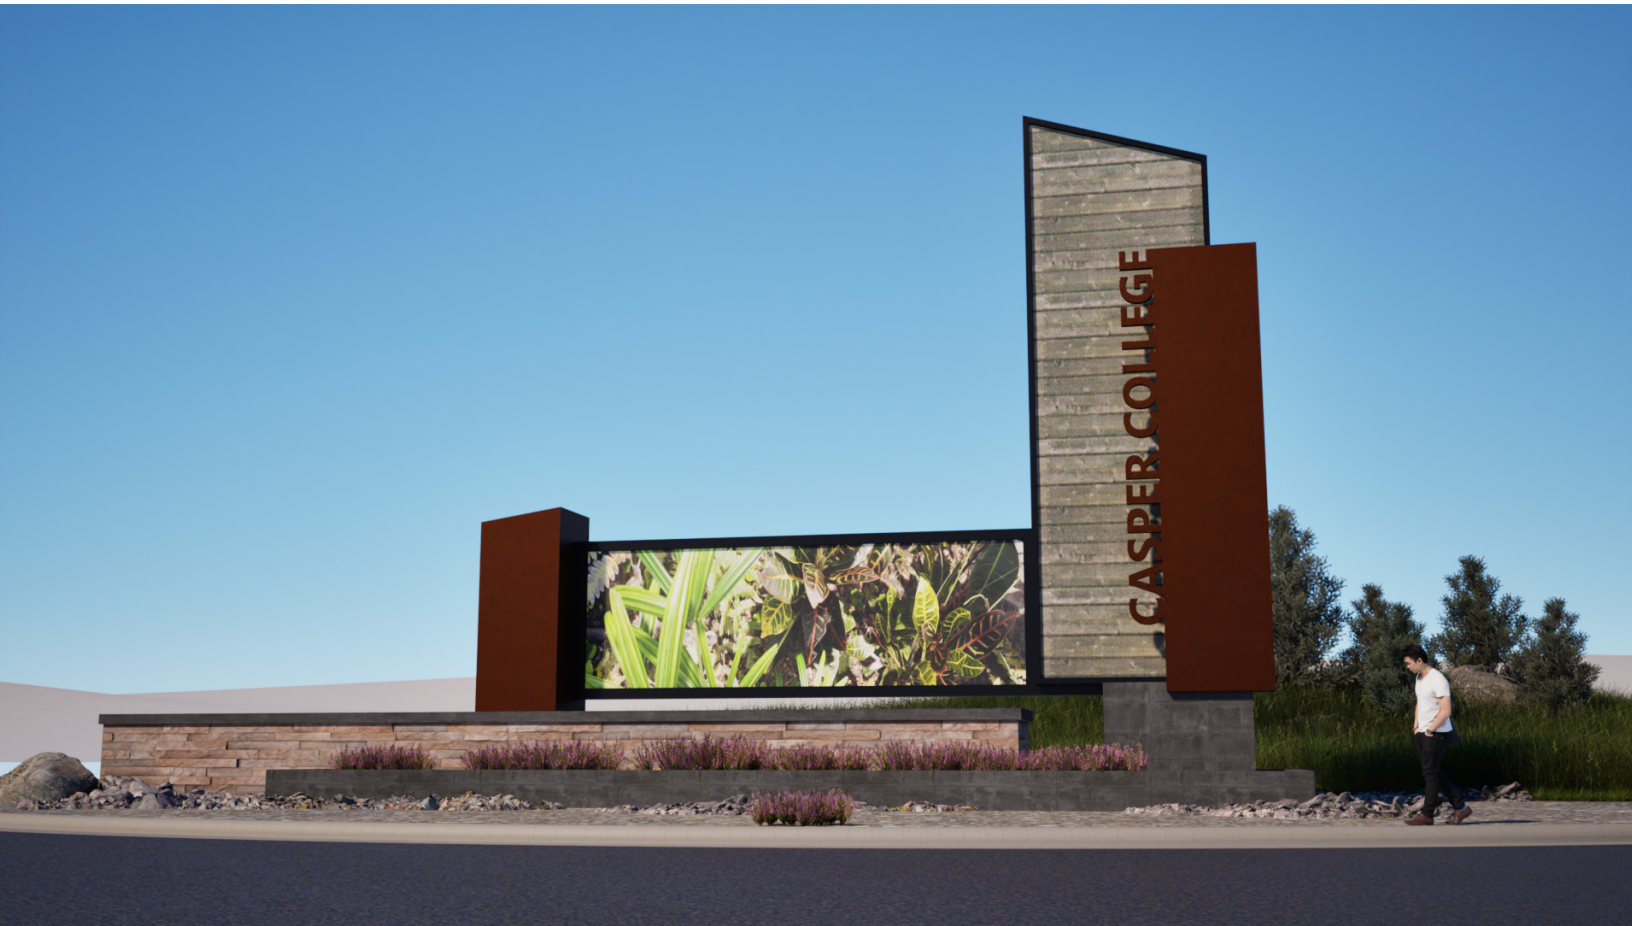
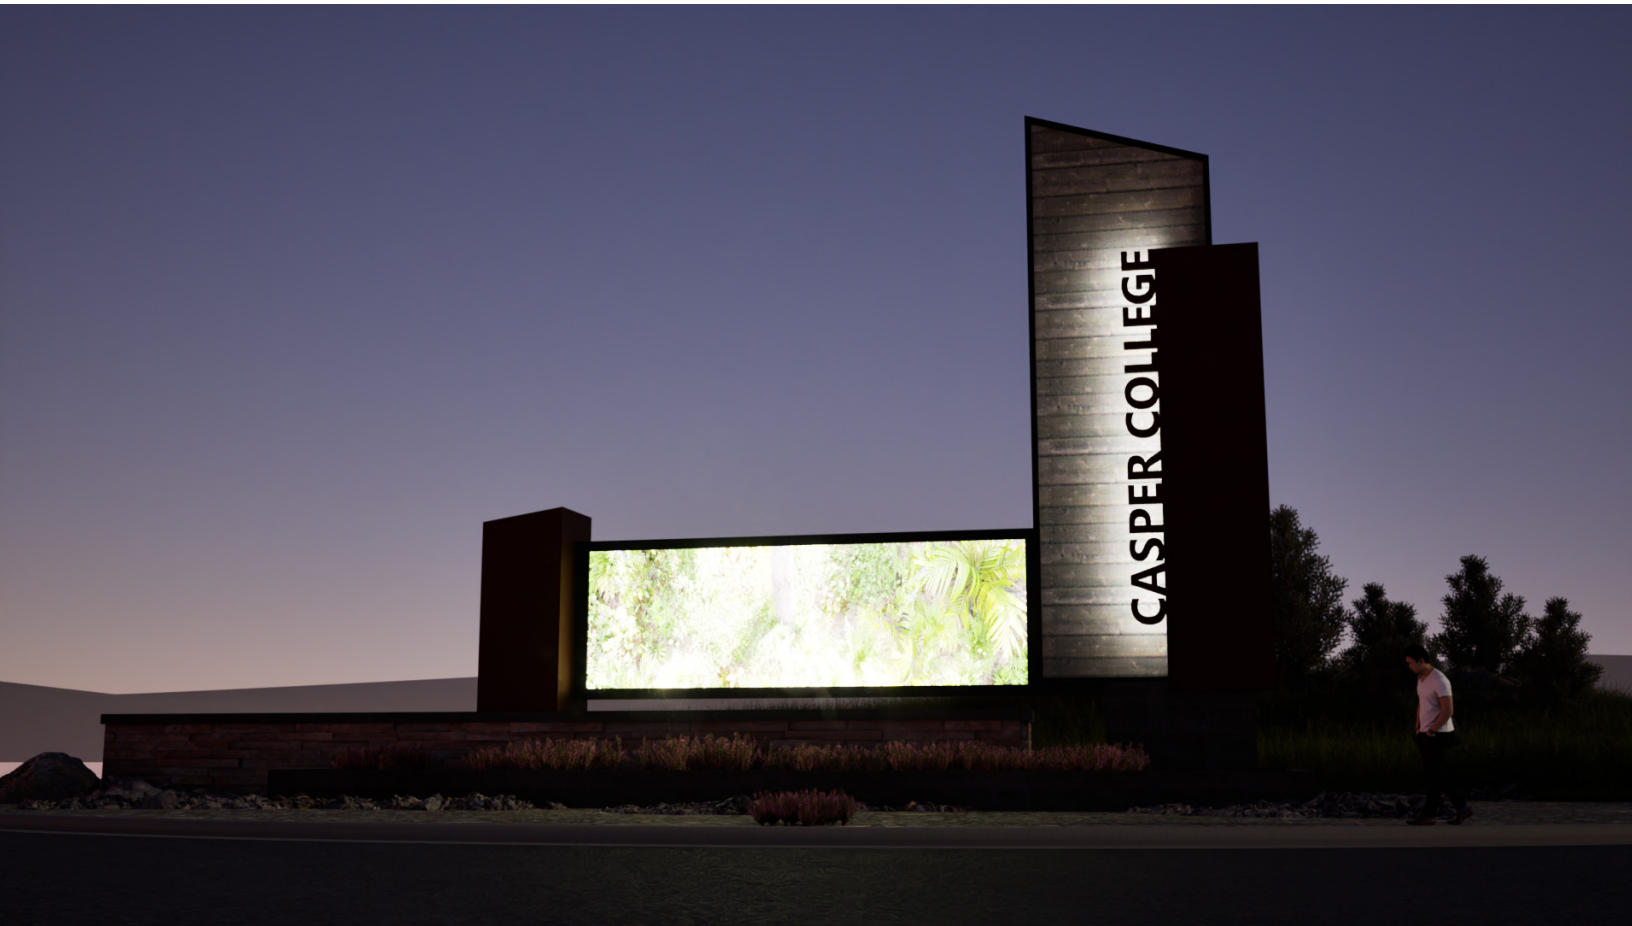
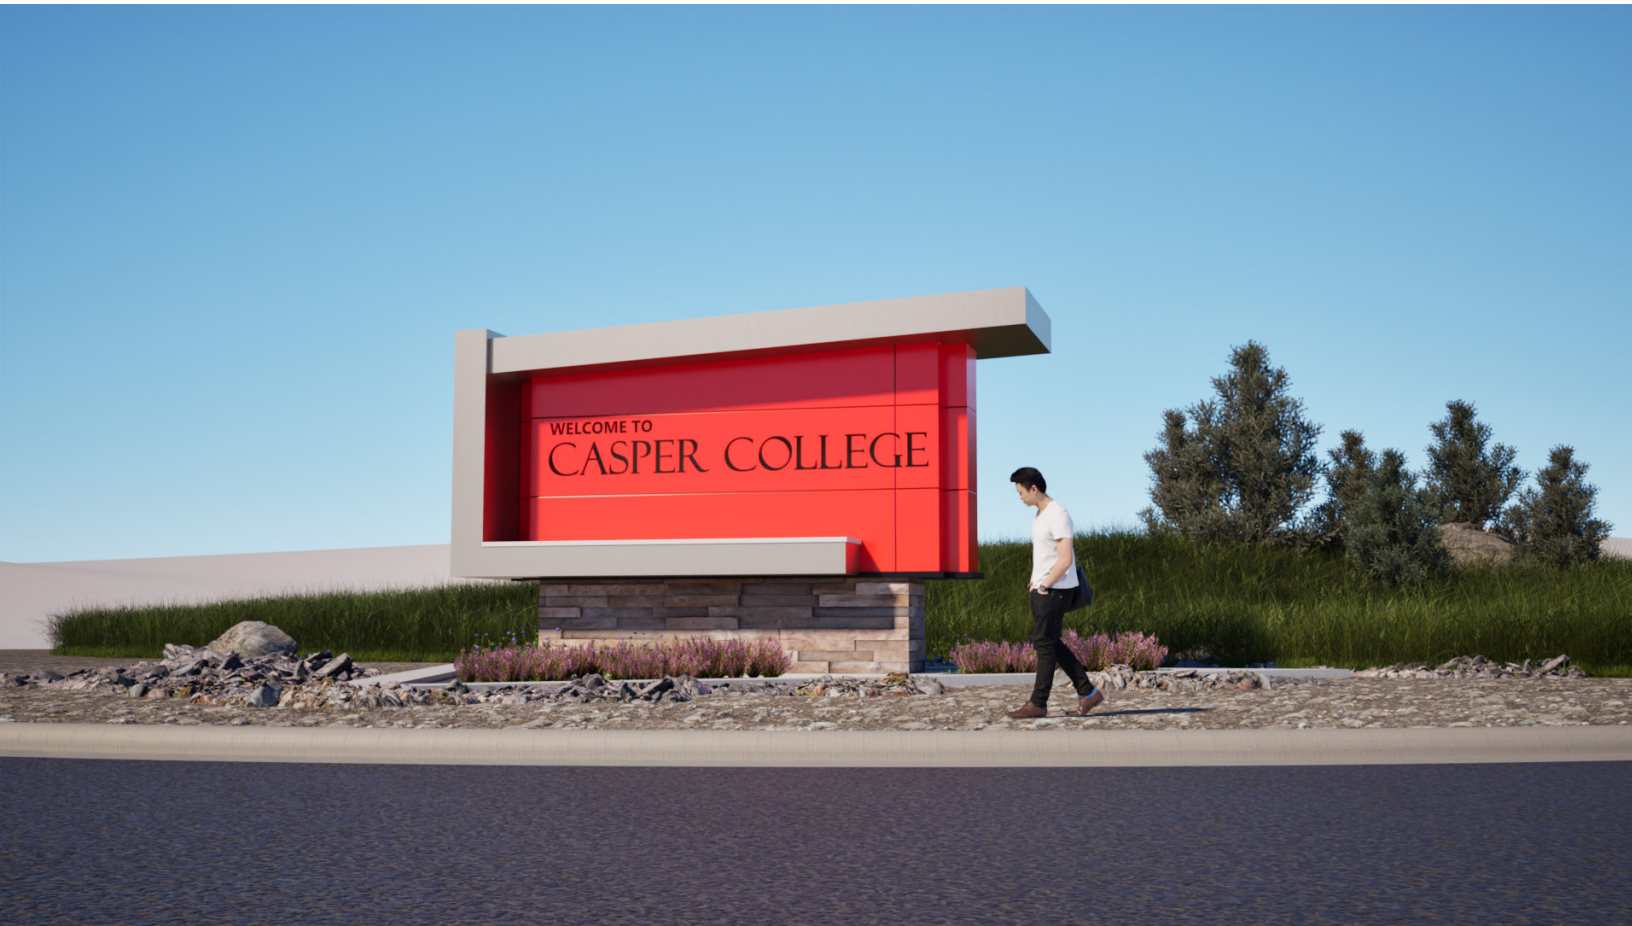
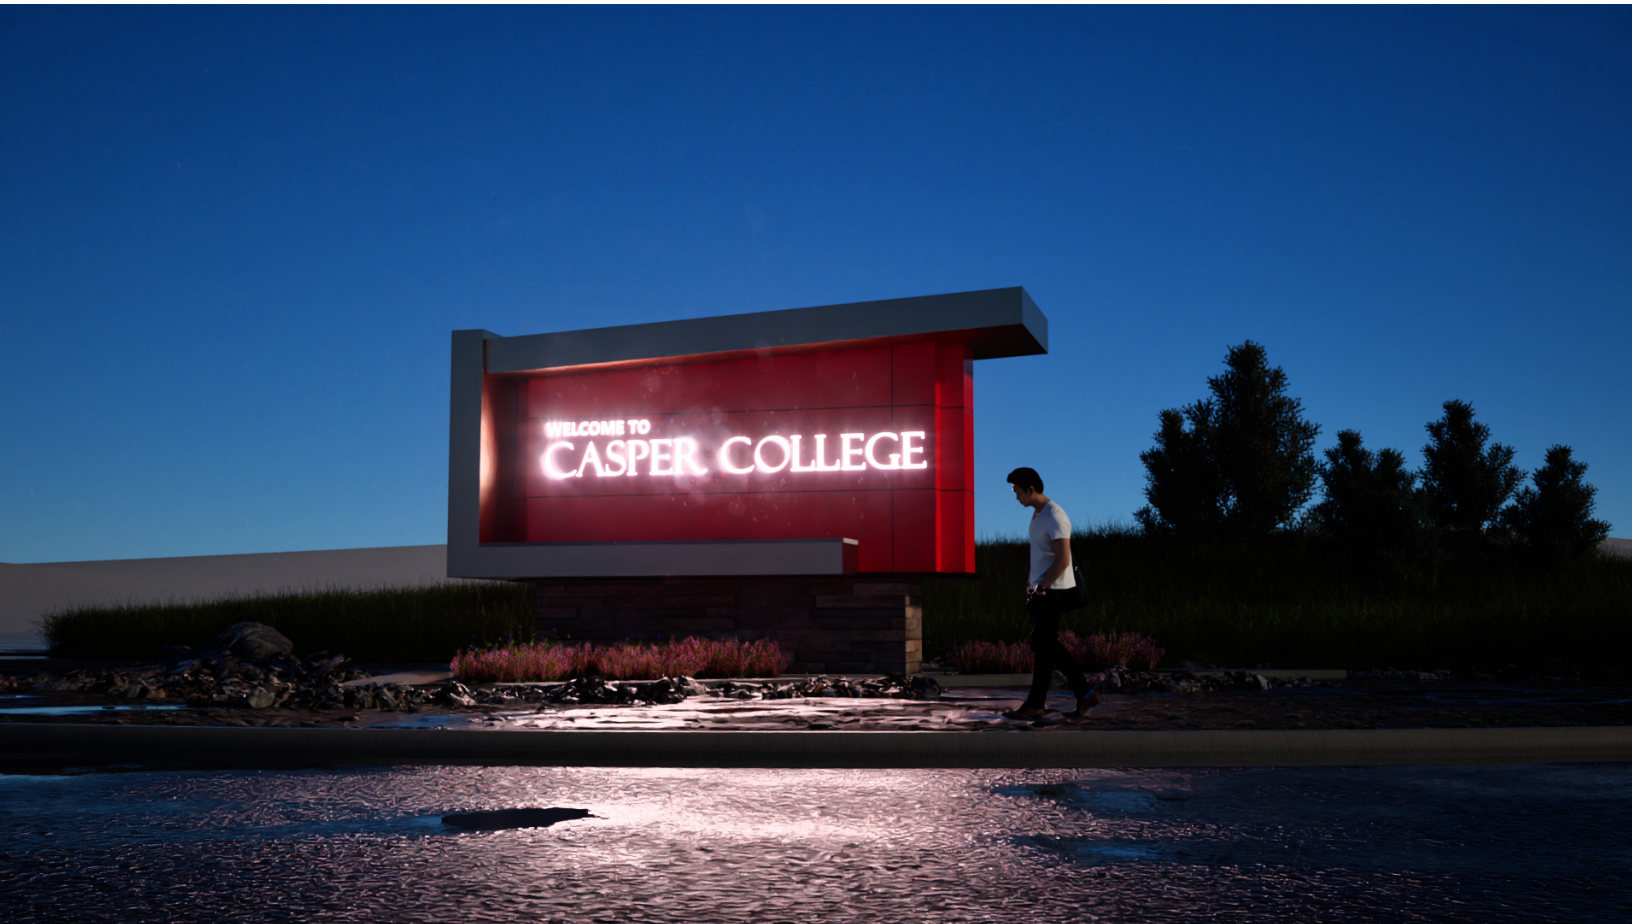
Potential monument sign options.

We would suggest a scaled down version at the other entry points on campus that maintain the brand. These could also have digital displays if desired. Establishing a hierarchy of entry points is important for directing traffic and will support better circulation. It is proposed that the signs with the LED digital displays be installed at the main campus entrances on Casper Mountain Road. This will also alleviate any light pollution from the signs disturbing neighbors or students living in the residence hall and apartments. Any lights used on the secondary entries will be designed to light the sign and not the surrounding areas.

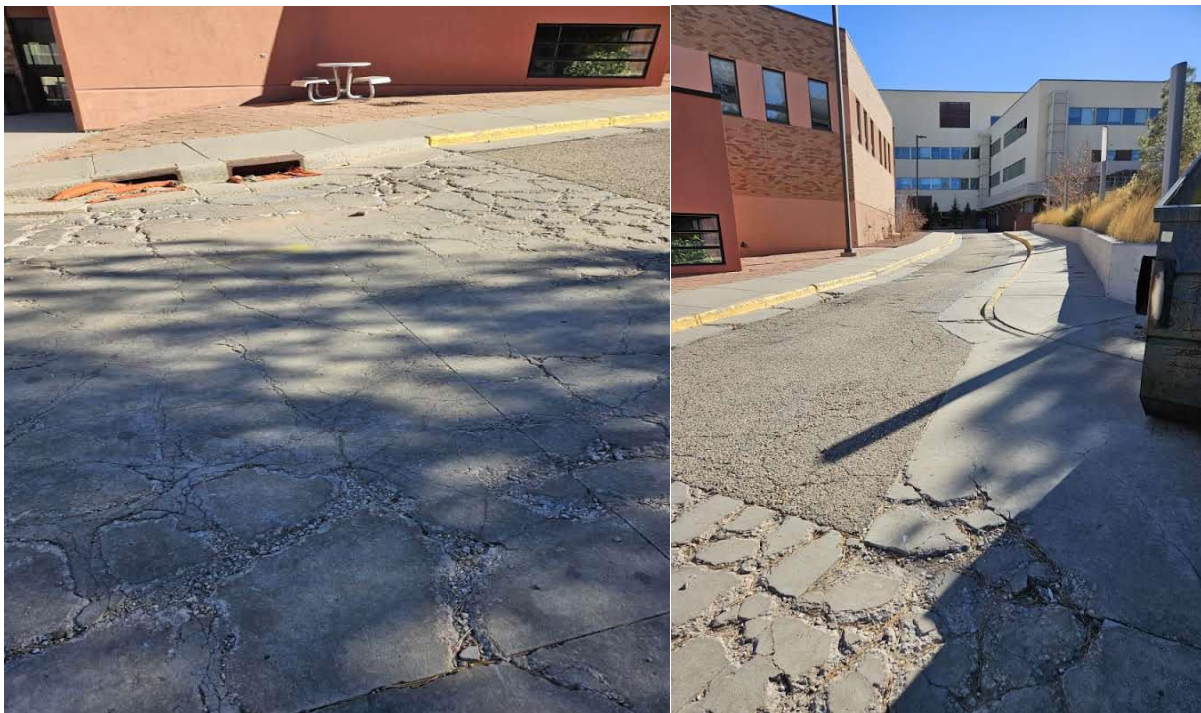
- The first problem area was in the alley between the Business Building and the World Physical Science Building. Storm water appears to bypass the inlets located here and cause damage to the concrete through freeze/thaw action. It appears that this issue may be caused by the inlets being clogged and undefined flow paths, resulting in the majority of water bypassing the inlets and causing damage to the surfacing further downstream.

*Photo 1: Poor drainage between Physical Science and Business Building*

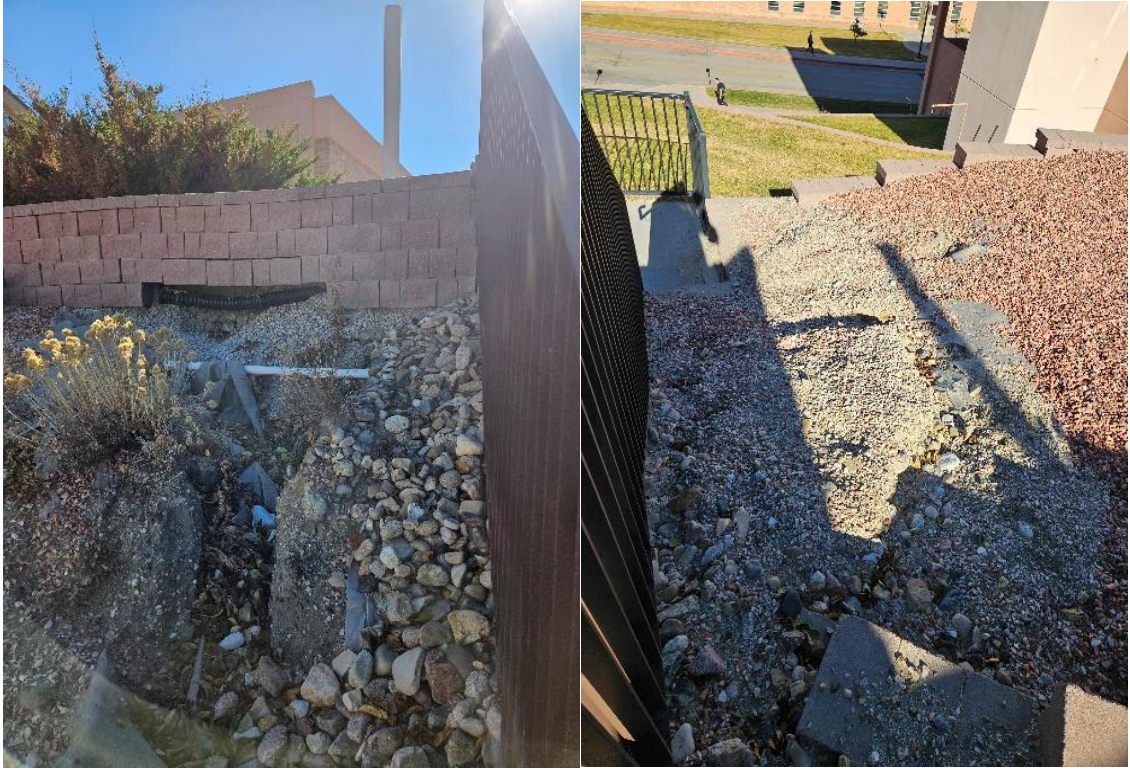
- Per discussion with Casper College Facility Staff, the Business Building drainage issues were noted as a stream of water flowing through the crawlspace in heavy storms. They have not been able to find the source of water or how it is going into the building. Currently, they are having to use sump pumps to help get the water out until after the storm subsides.

*Photo 2: Damage downstream of Physical Science and Business Building*

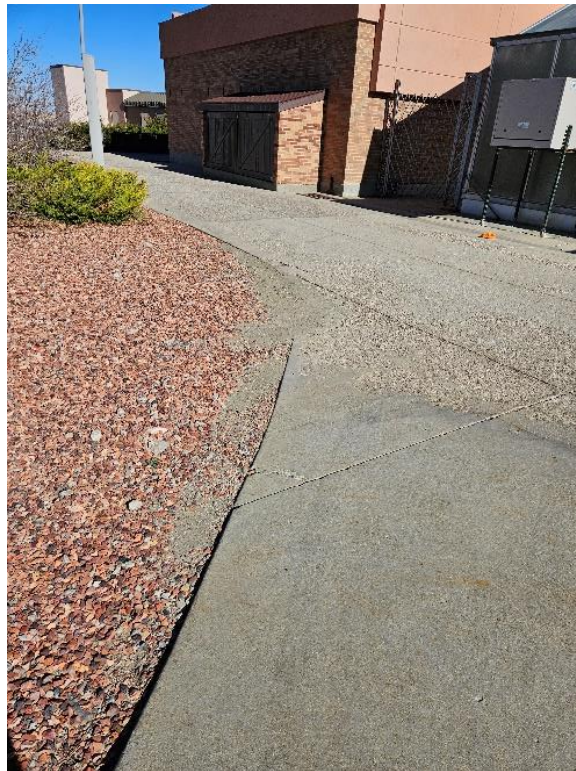
- The second location is along the west side of the Loftin Life Science Building where there appears to be standing water along the landscape and walking path and near the main west entrance to the building.

*Photo 3: Evidence of sediment accumulation and ponding water*

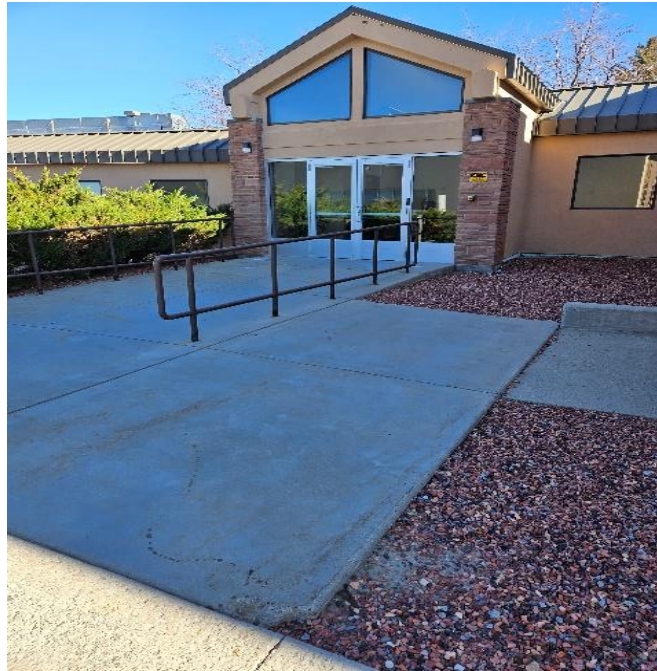
*Photo 4: Poor drainage near west entrance to Loftin Life Science Building and Aley Hall*

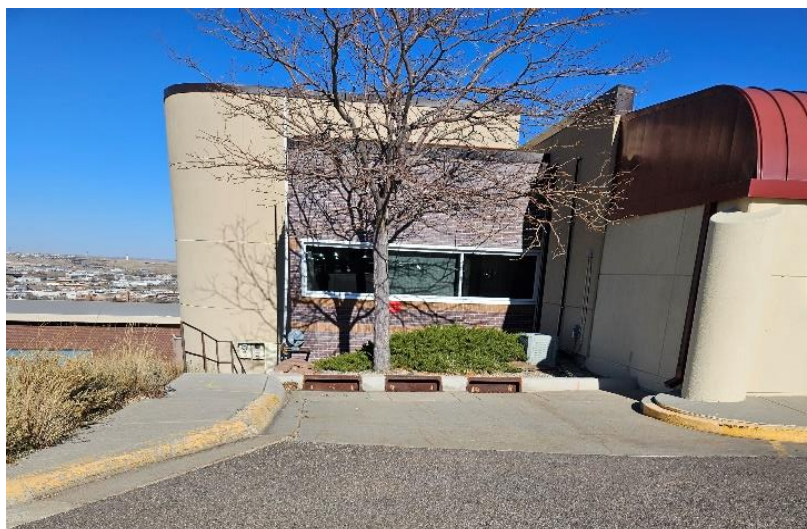
*Photo 5: End of parking lot in front of Business Building*

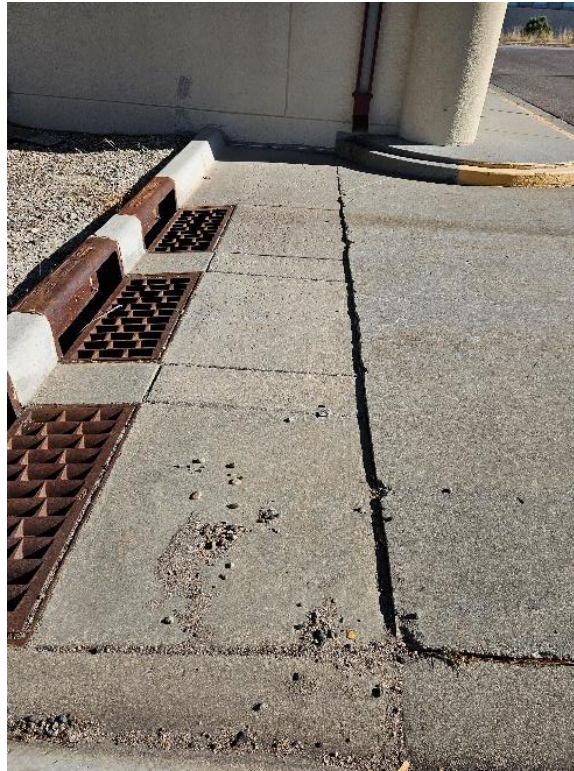
*Photo 6: Drainage challenges at Business Building*

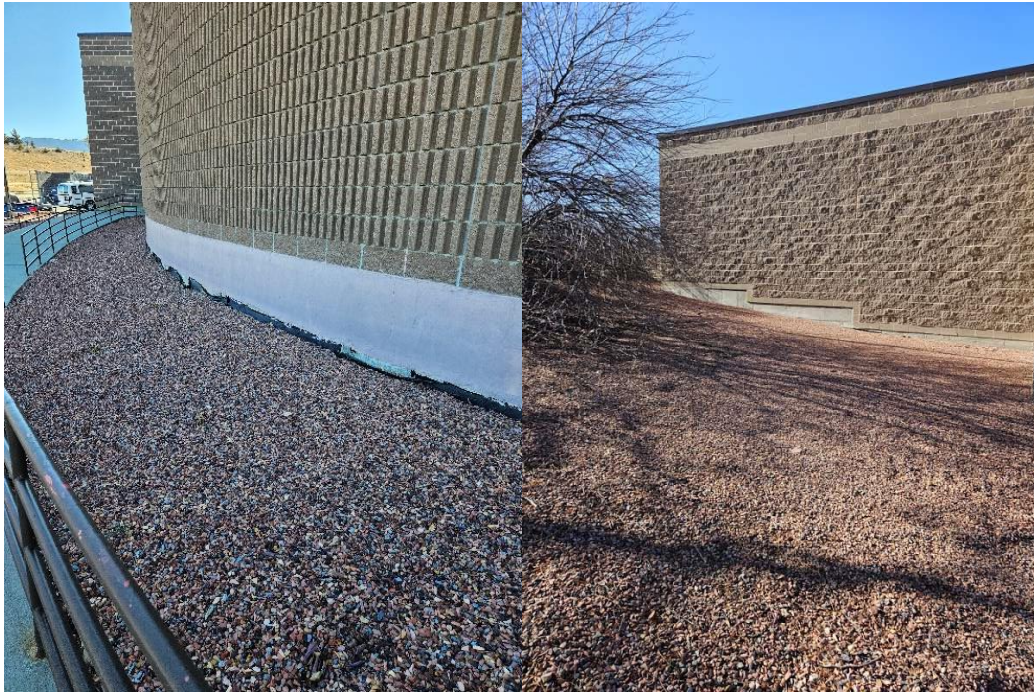
*Photo 7: Inadequate landscaping and cover around the Krampert Theater*

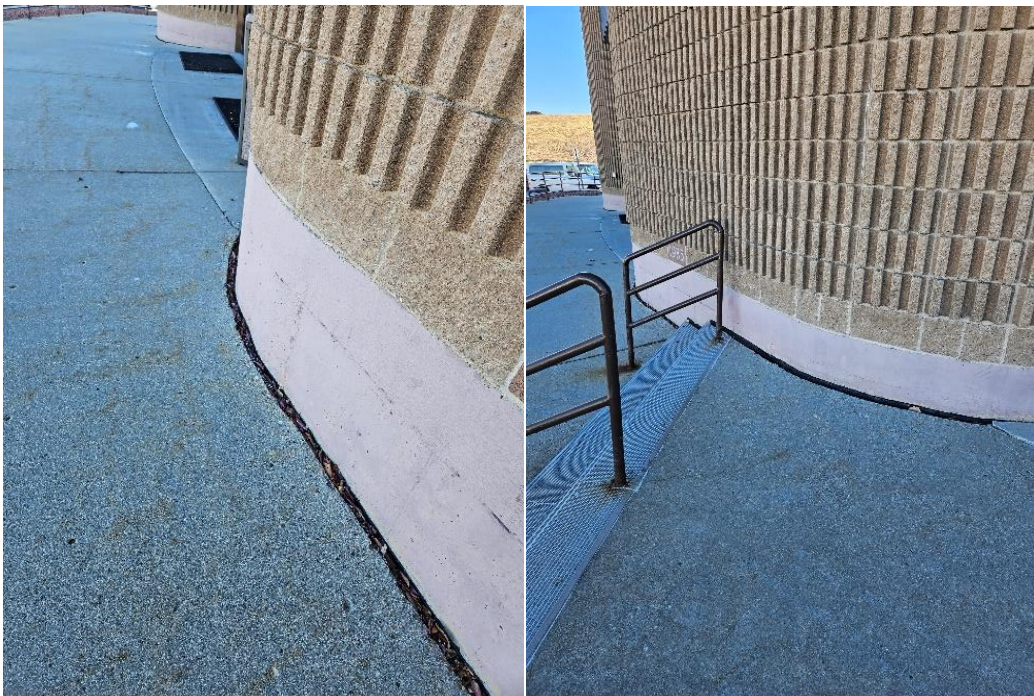
*Photo 8: Concrete settlement along north face of Krampert Theater*

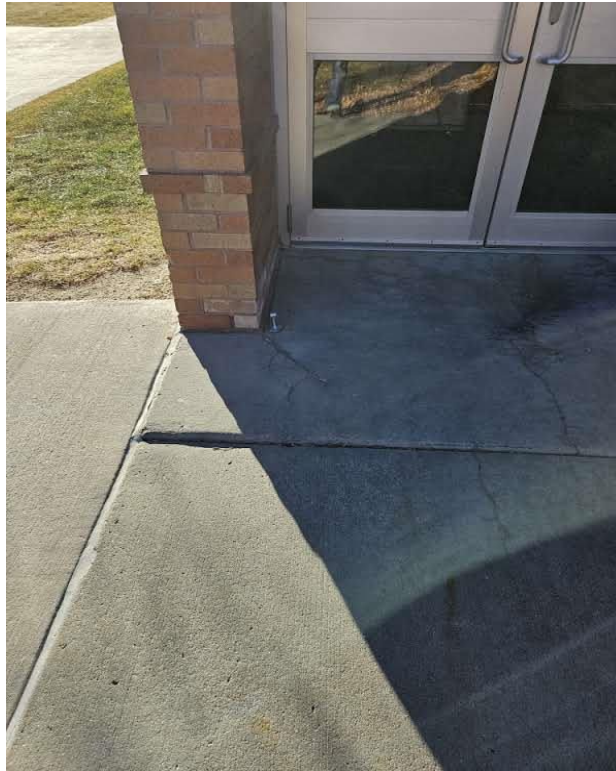
*Photo 9: Pavement movement at the Saunder's Health Science west entrance*

There are several locations on campus where the routes from the parking lots to the buildings do not appear to meet ADA Requirements. This is due to the change in elevation between sidewalk panels and vertical transitions due to the concrete pavement or asphalt pavement moving and/or settling.

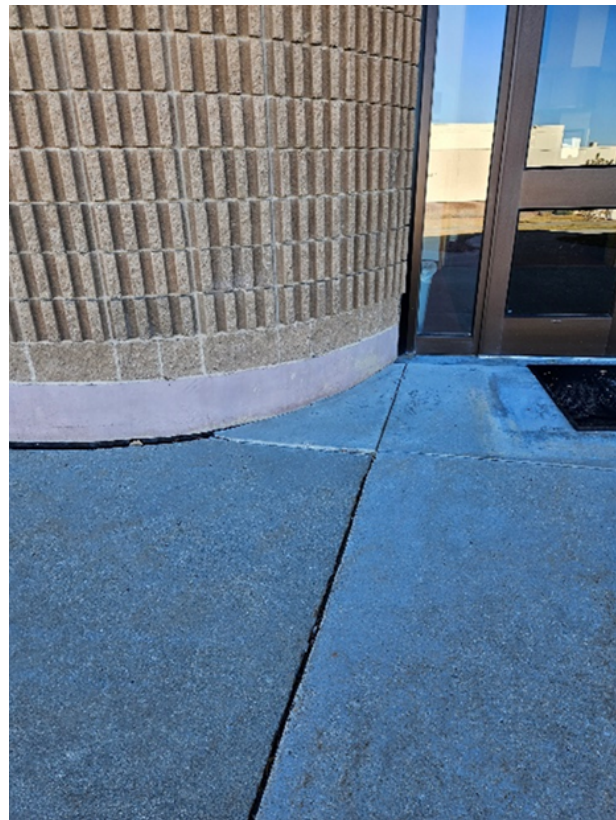
*Photo 10: Pavement movement at the north side of Krampert Theater*

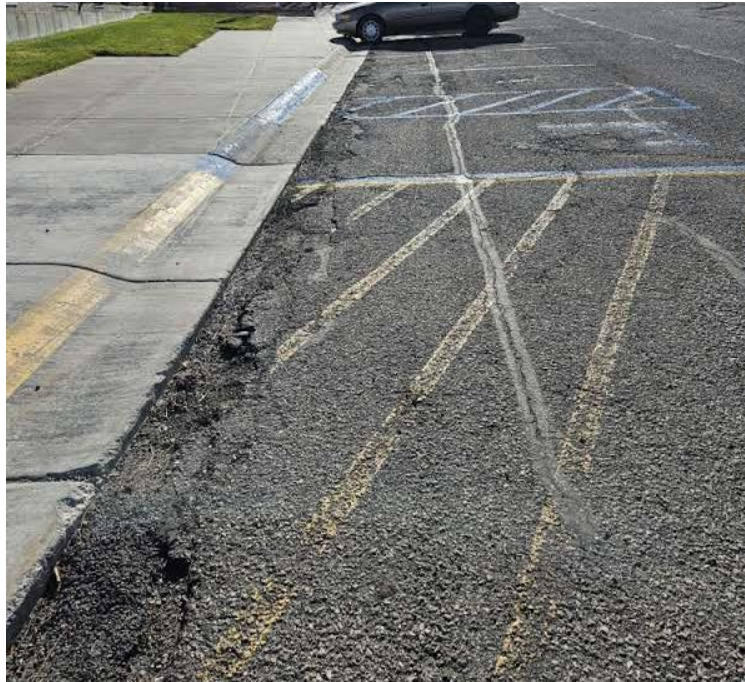
*Photo 11: Non complaint ADA Parking and routes at the Krampert Theater*

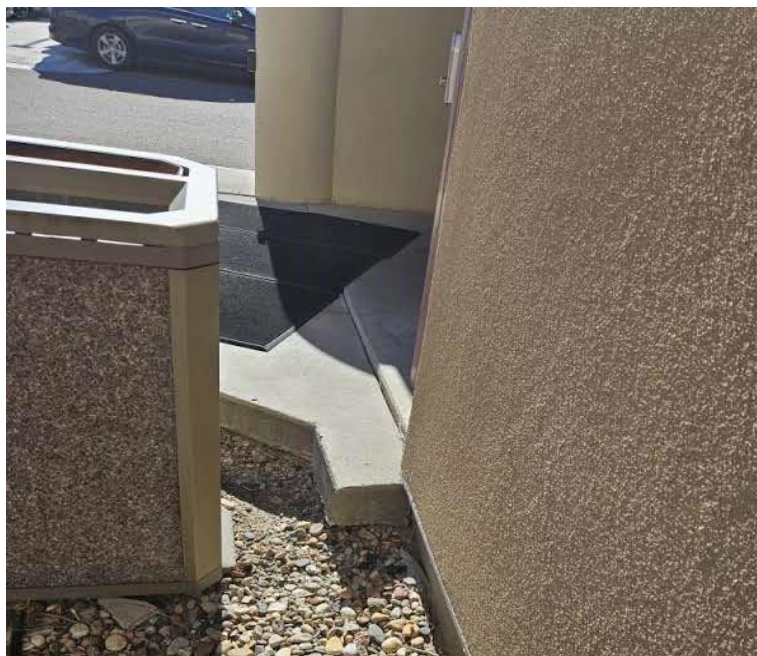
*Photo 12: Pavement movement at the Business Building south door*

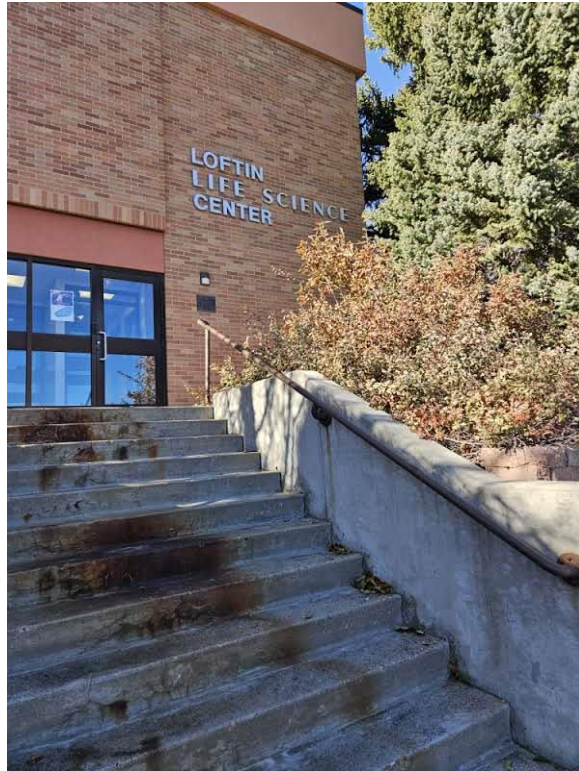
*Photo 15: No direct ADA entrance to Loftin Life Science Building*

Throughout the campus, there are several connections from sidewalks to existing buildings or parking lots that consist of only stairs which don't meet ADA requirements. There are several buildings that lack sufficient direct ADA access to distinguished walking paths.

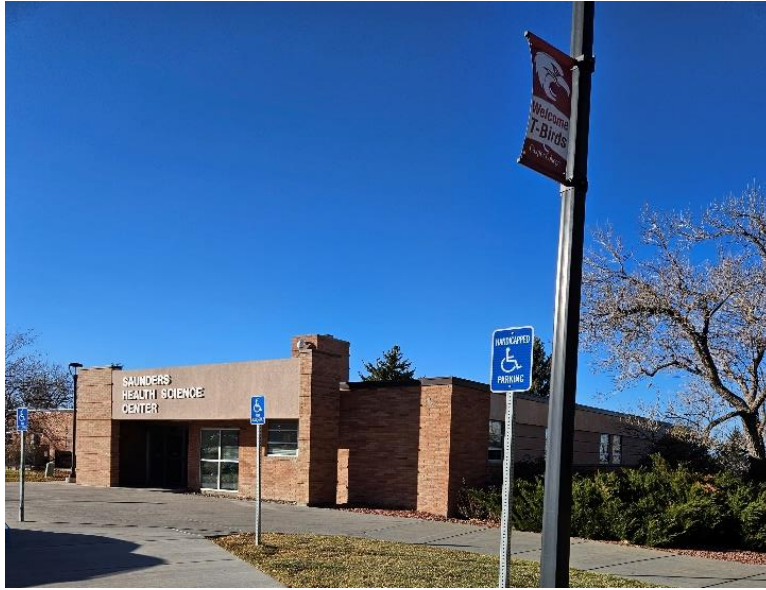
*Photo 16: Entrance signage at the Saunders Health Science Building east entrance*

The campus does not have sufficient central wayfinding or a building identification system and does not have a parking lot wayfinding system. Building identification on the campus would consist of building names in white lettering on only one entrance to the building. Future traffic studies should also investigate the need for additional cautionary and advisory signs for pedestrian crossings including signaled crossings at locations of high pedestrian traffic.

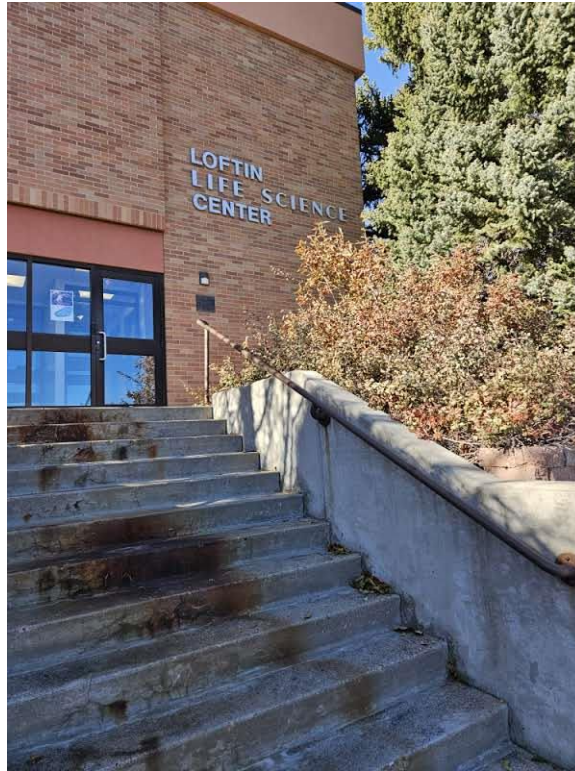
*Photo 17: Entrance signage at the Loftin Life Science Center east entrance*

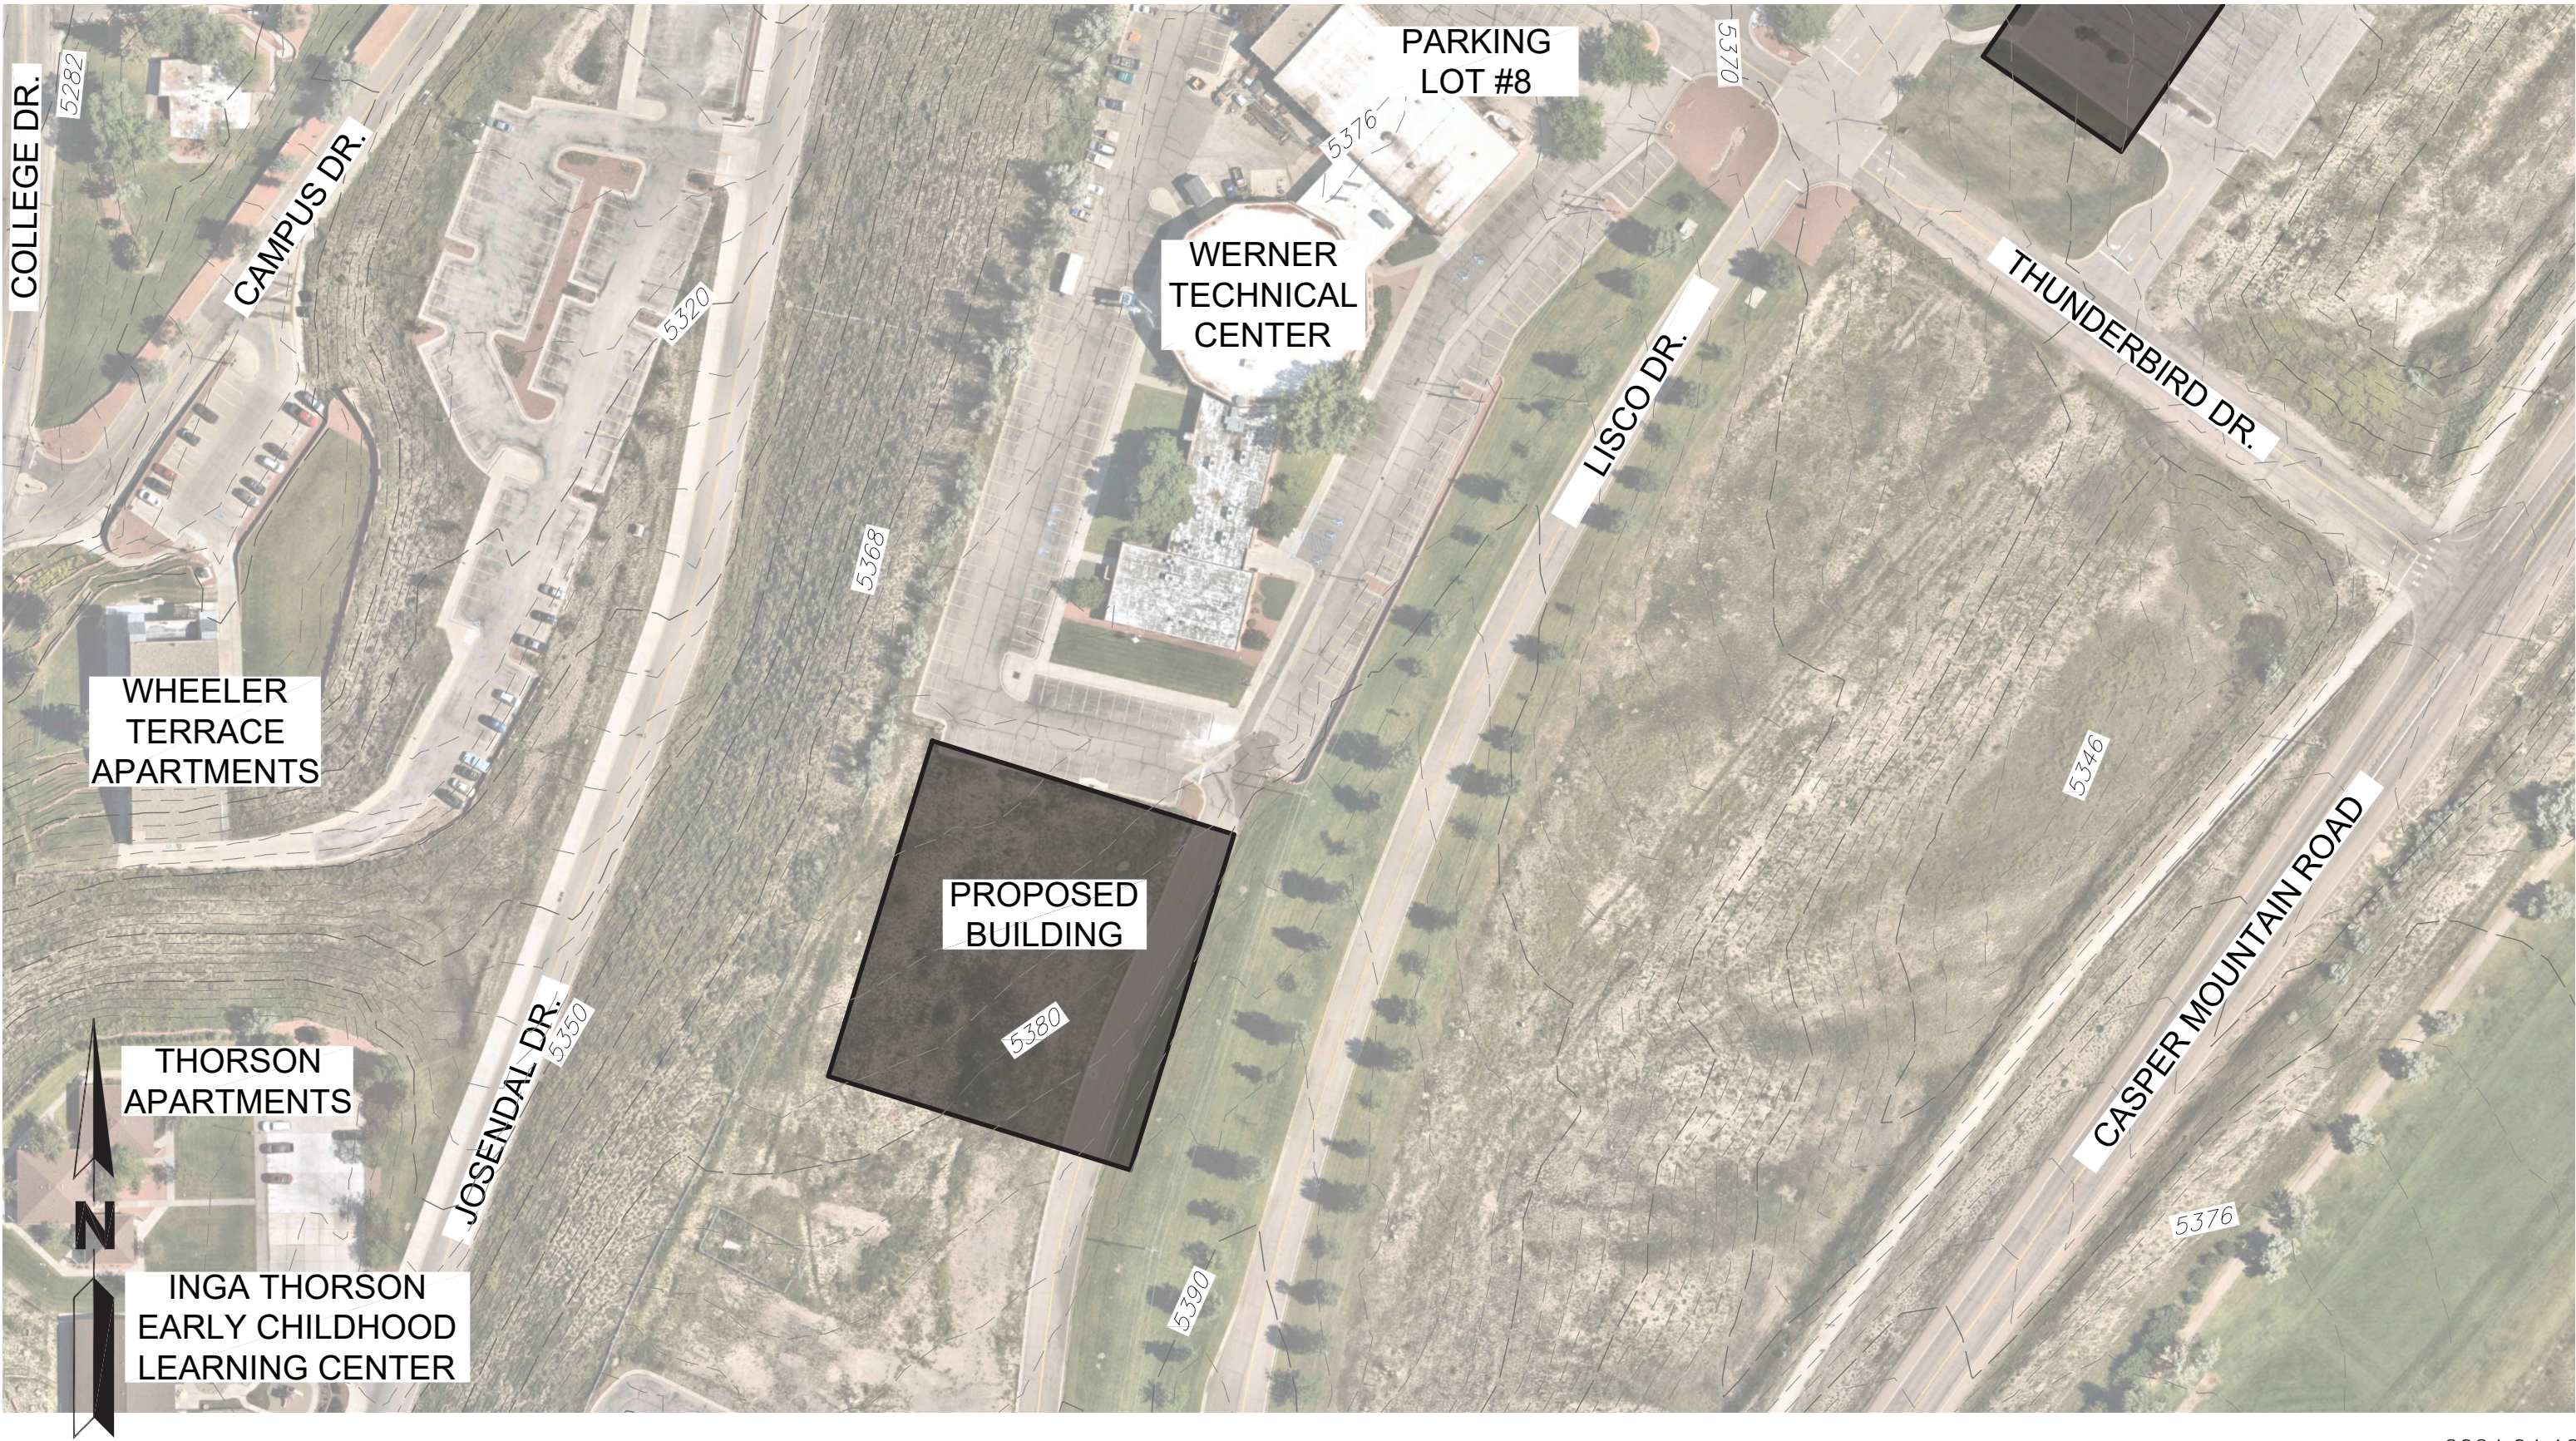
Industry Tech: Stand Alone Option (Option 2A)  
Location: South of Werner Tech Building

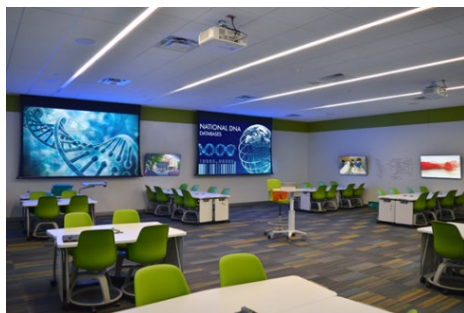
Active Learning Classrooms should support two modes: Presentation Mode and Breakout Mode. Presentation mode will present content on the main display as well as mirroring content on all the table displays. Breakout mode will allow the students at each station to share content with the local display and collaborate. The local displays can be wall mounted or on mobile carts that allow additional furniture flexibility.

The instructor will have a touch down location or small lectern which will include a resident computer, auxiliary input connections, and document camera. The system supports local and remote collaboration via web-conferencing software loaded on the local computer (e.g., Zoom, Teams, etc.) and camera/ceiling microphones.

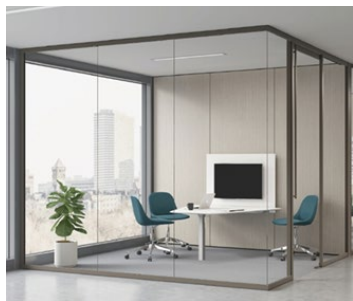
The display system will consist of one large flat panel display mounted to the wall. Users will be able to connect the video output of their laptop/tablet to the flat panel display through multiple auxiliary audiovisual connections.

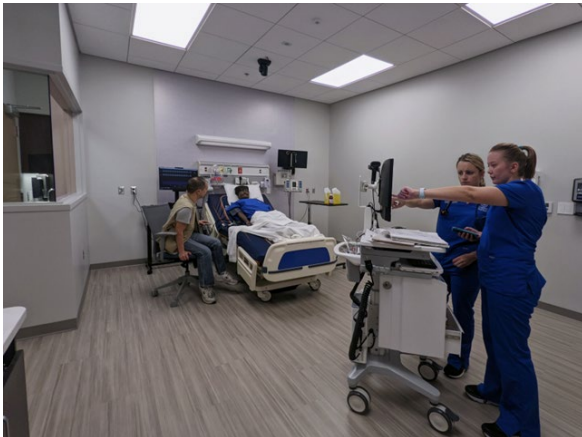
The Simulation Rooms will be able to support actors / confederates as well as high-fidelity medical manikins. Multiple video cameras and wired/wireless microphones will be used for recording in these spaces as well as the associated medication area. Input panels will enable alternate video source and manikin physiological data capture. The video and audio signals will be fed to the medical simulation capture system for viewing and archiving.

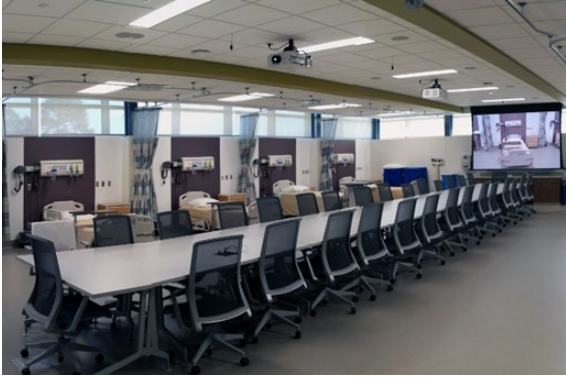
One (1) of the bed stations will be designated as a demonstration station will allow for the capture of instructors or students performing training via a ceiling microphone, camera, and speaker connected to the medical simulation system. Each of the beds will include a monitor/computer for Health Records and Web based learning. The demonstration station as well as the lecture content can be pushed to these bed side displays.
