# Casper College Campus Master Plan Refresh

+ hord | coplan | macht

### EXECUTIVE SUMMARY

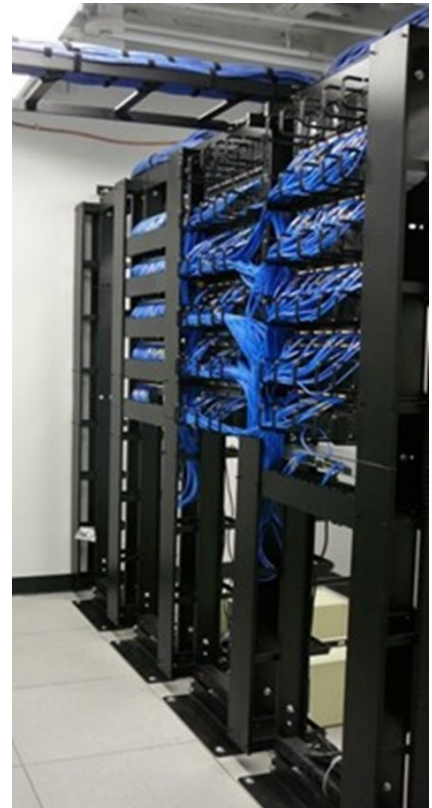
Wired building network systems are known as structured cabling systems. Structured cabling systems originate in the Telecom Rooms and extend throughout the building from ER to TR (backbone) and from TR to the end user locations (horizontal). The backbone cabling system between Telecom Rooms consists of fiber and copper cables and connects each TR via home-run cables to a Main TR within the building. The horizontal cabling system consists of twisted pair cables such as CAT 6 or CAT 6A and is visible to the end user in the form of wall faceplates. All horizontal cabling routes to the Telecom Rooms should be through cable baskets located in corridors and other approved support systems as required.

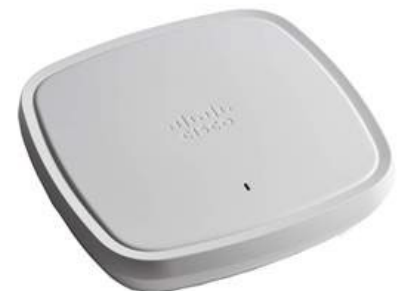
A building-wide wireless network should be designed into the each new construction building and building renovations to augment the traditional wired network. Access points should be located below finished ceilings and be activated as needed to provide full building-wide coverage. The wireless infrastructure design should be based on the latest IEEE-802.11 standard (802.11ax) known as Wi-Fi 6 Wave-2 and is capable of adapting to and supporting recent standards such as 802.11be WiFi 7 and future standards.

Power over Ethernet (PoE) technology should be deployed to simplify installation and increase system flexibility by centrally locating all power requirements for wireless access points. This design methodology greatly increases the availability of network bandwidth by adding the capability of connecting to the network via multiple frequencies and channels. The ultimate goal of the wireless system design is to allow for wireless coverage for the entire facility, including adjacent exterior areas, utilizing high density and dynamic load balancing wireless network standards. It is anticipated that high density spaces such as lecture halls and classrooms may require multiple, dedicated access points.

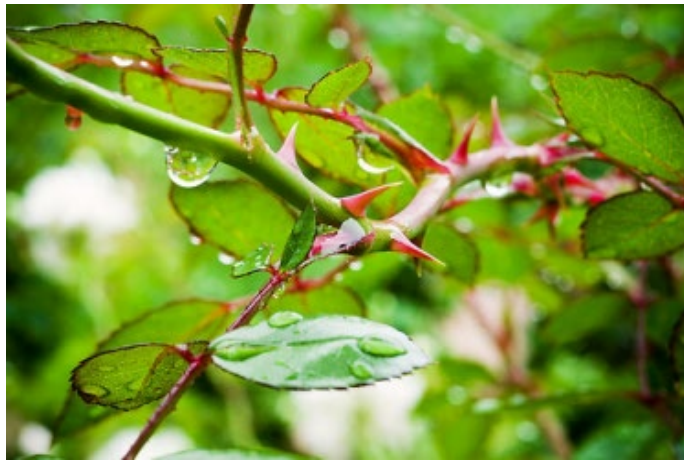
From the perspective of Natural Surveillance, these items are ideal in that they offer no real hiding places. They provide a level of deterrence but little to no visual obstruction, which raises the probability of detection for the potential intruder.

Natural Surveillance is the design principle, which calls for creating an environment where the occupant has an enhanced ability to observe the surrounding environment and the potential offender will have a heightened perception of their increased risk of being observed. The design principles involved include creating good sight lines and minimizing visual obstacles so that from a given location the occupant has a high degree of visual control. People will always feel safer when they can easily see and be seen.
