Unison™ Technical Support and Service Field Service Report

CRM Case #	69-38376	Job Name:	Casper College
Sales Order #	210261	Serial # or Tags:	AHU-1
Ship Date:	2/28/2011	Rep Office:	LONG

To determine why the building is vibrating below the Innovent unit and to do a complete review of the unit condition and operation.

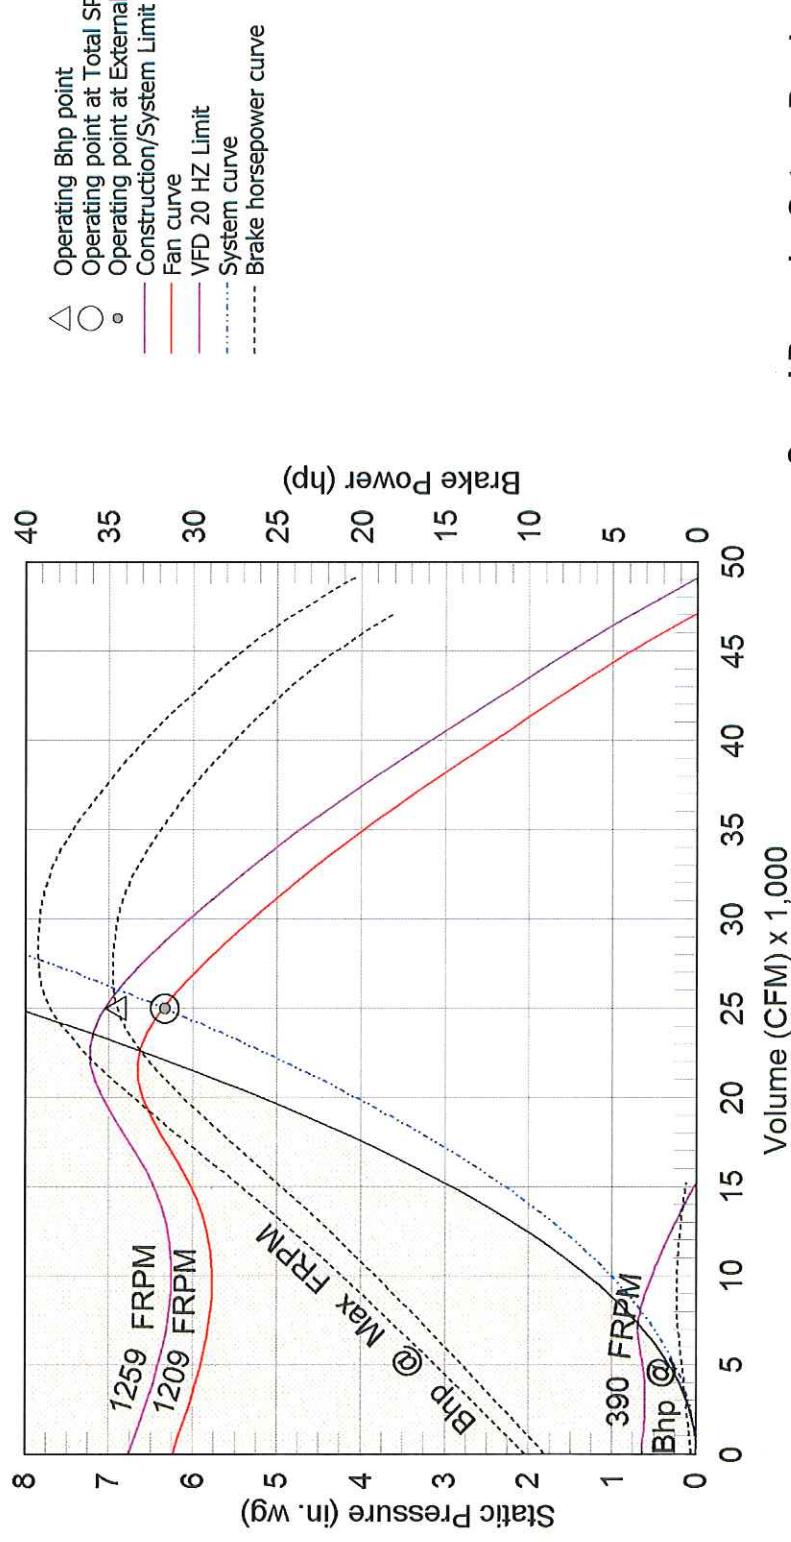
40-APH-4-95-II-400
Chart Type: Min/Max Speed

Requested Volume (CFM)	25,000	Actual Volume (CFM)	25,000	Fan RPM	1209
External SP (in. wg)	6.34	Total SP (in. wg)	6.34	Operating Power (hp)	34.41
Elevation (ft)	5,289	Airstream Temp. (F)	70	Static Efficiency (%)	72
